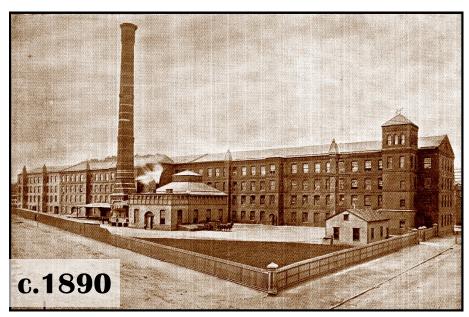
BABOUR 1: c.1890 looking SW . Original 1877 building is on right side, with 1890 addition to left of smokestack.

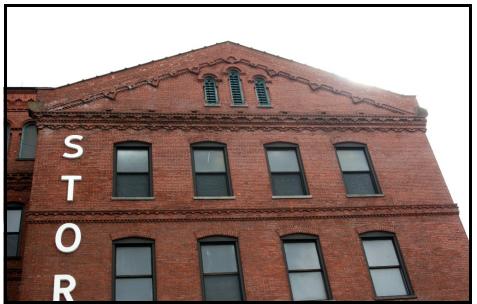
BABOUR 3: detail view of 1877 building gable, looking S.

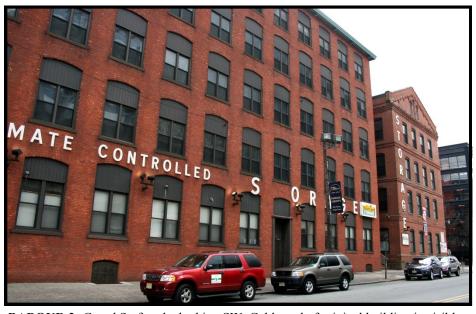
BABOUR 2: Grand St. façade, looking SW. Gable end of original building is visible at right, 5-story 1910s addition to left.

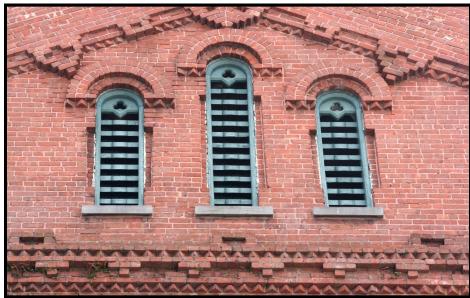
BABOUR 4: close up view of 1877 building gable, looking S. this sample of meticulous brick corbelling technique is outstanding.

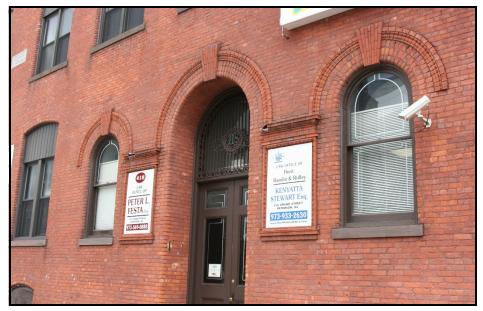
BABOUR 5: oblique view looking SW from Kearny St. showing Totowa Ave. façade of the 1910s addition.

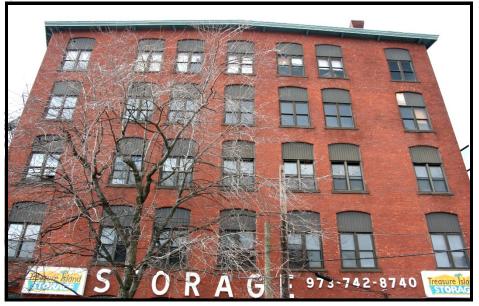
BABOUR 7: overview of gable end of 1910s addition looking W from Prince St.

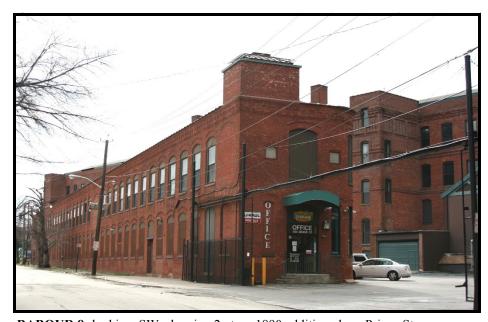
BABOUR 8: looking SW, showing 2-story 1890 addition along Prince St.

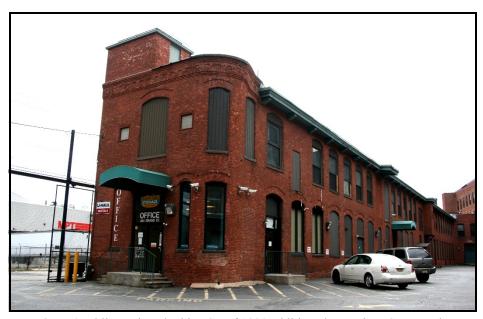
BABOUR 9: oblique view looking SE of 1890 addition along Prince St. Note the rounded brick detailing in the cornice and lintels.

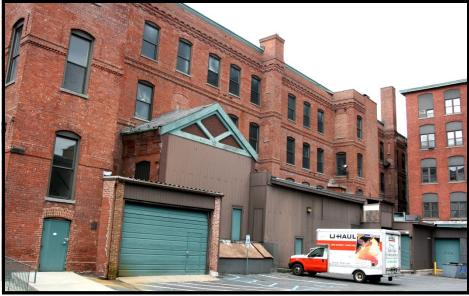
BABOUR 11: oblique view looking NW into 1877 building. The rolling door and trestle area at center mark the location of the Boiler House that has been removed.

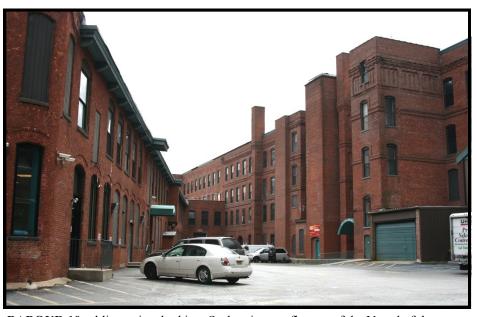
BABOUR 10: oblique view looking S, showing confluence of the V-end of the courtyard area. The first addition is at right center.

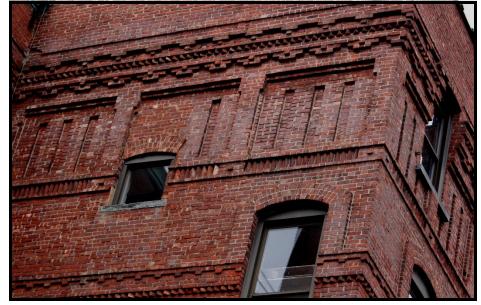
BABOUR 12: close up view looking NW from interior courtyard. Note the extensive brick detail and corbelling in this view of the 1877 original building.

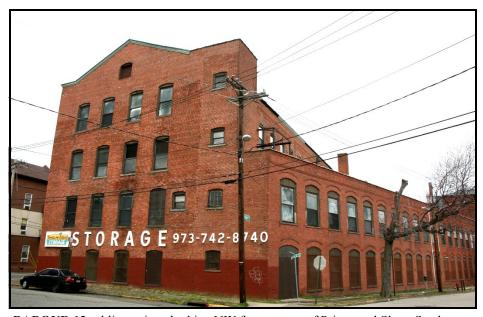
BABOUR 13: oblique view looking NW from corner of Prince and Slater St. showing gable end of 1890 4-story addition.

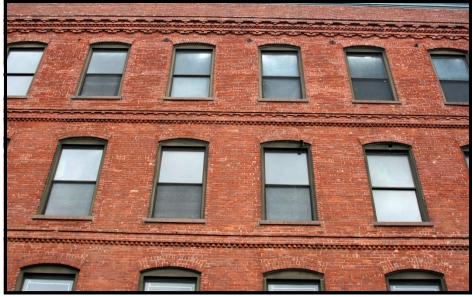
BABOUR 15: detail view looking E, showing the original building along Spring St.

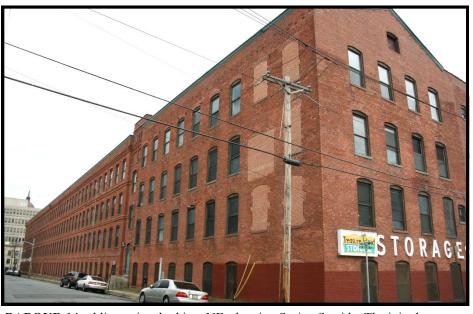
BABOUR 14: oblique view looking NE, showing Spring St. side. The joint between the 1877 building and the 1890 building is evident at left of center.

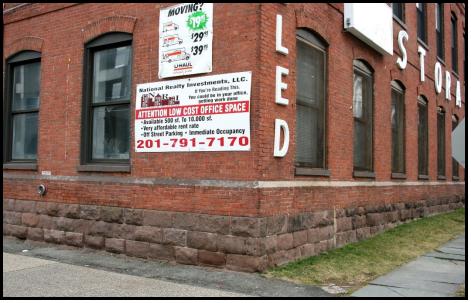
BABOUR 16: looking SE, showing cast stone water table and brownstone foundation of the 1877 bld.
