## I.A. HALL MILLS

94 Fulton Street, Paterson, NJ B 3112 L 03, 04, 05

Photographs, historic / contemporary

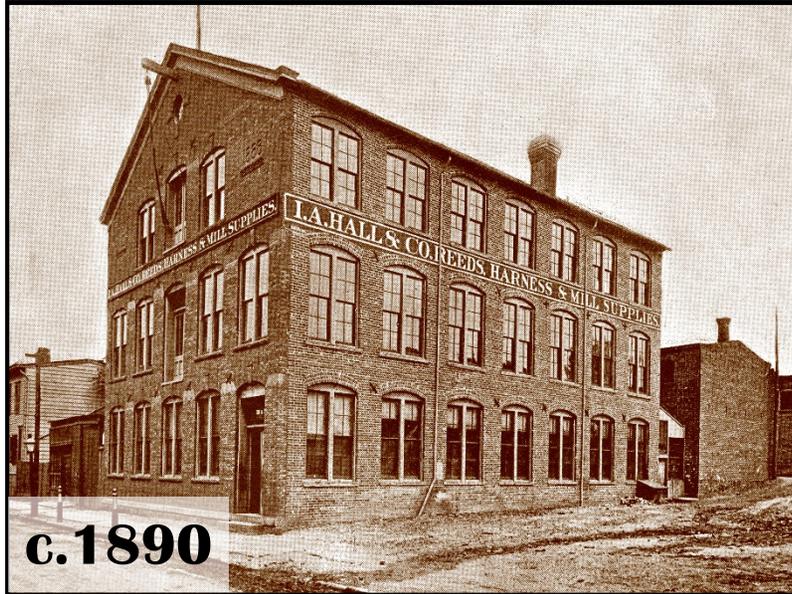
**HALL 1:** Isaac Hall's mill on Division St. c. 1890. Hall developed a campus in that area where he expanded his mill supply business as his products became widely known. He invested profits by erecting a large tenant mill on Fulton St. c. 1899,

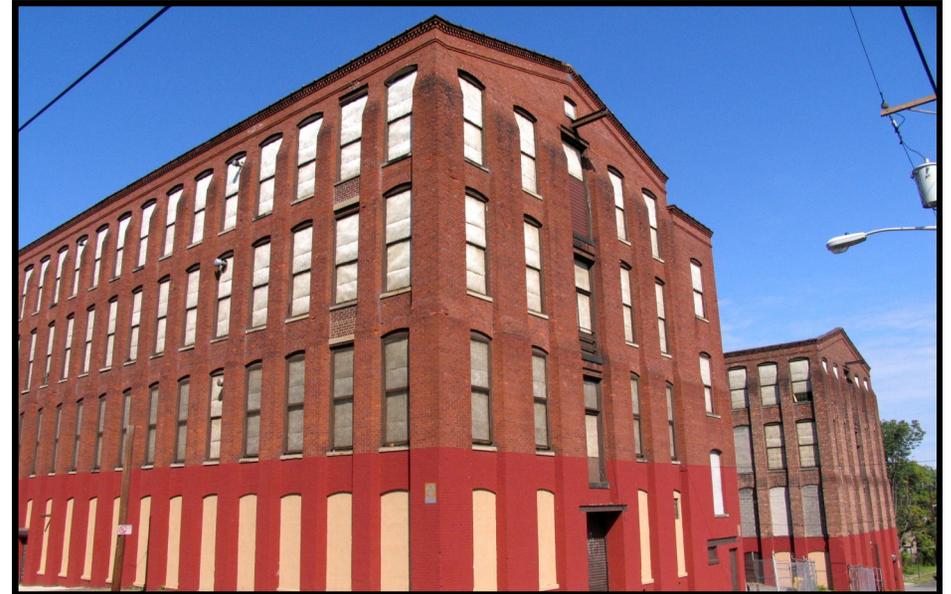
**HALL 2:** Oblique overview looking NW from corner of Harrison and Summer St., showing East gable ends of the twin Hall mills.

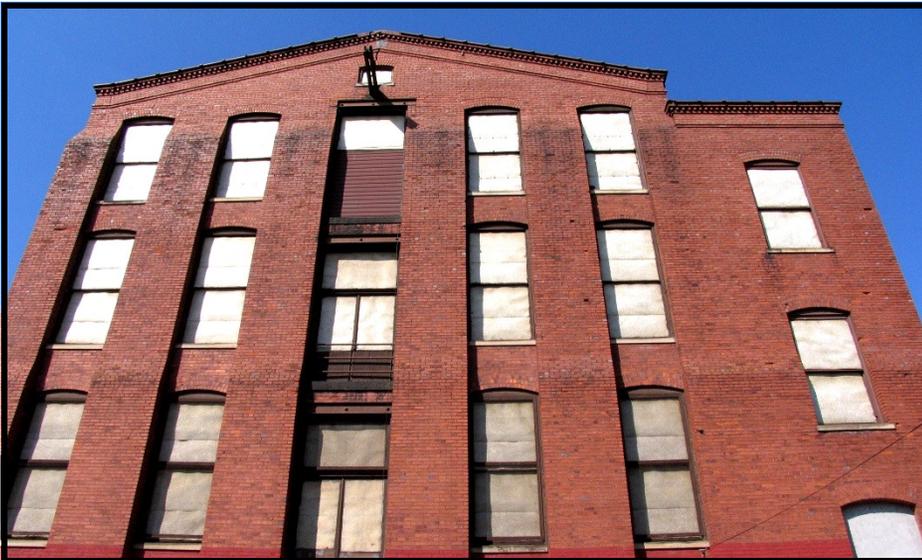
**HALL 3:** Detail view of 1910s building east gable end, looking W.

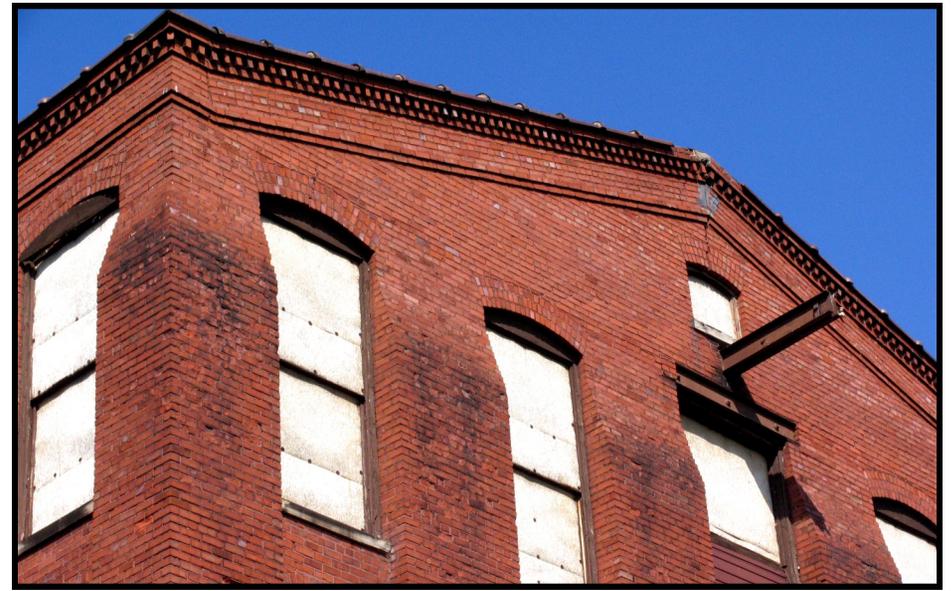
**HALL 4:** close up view of 1910s building east gable end, looking NW. Details of interest are clearly shown: meticulous brick corbelling and running course work of the closed eaves, the terra cotta coping, and the gradual-stepped buttressed pilasters.

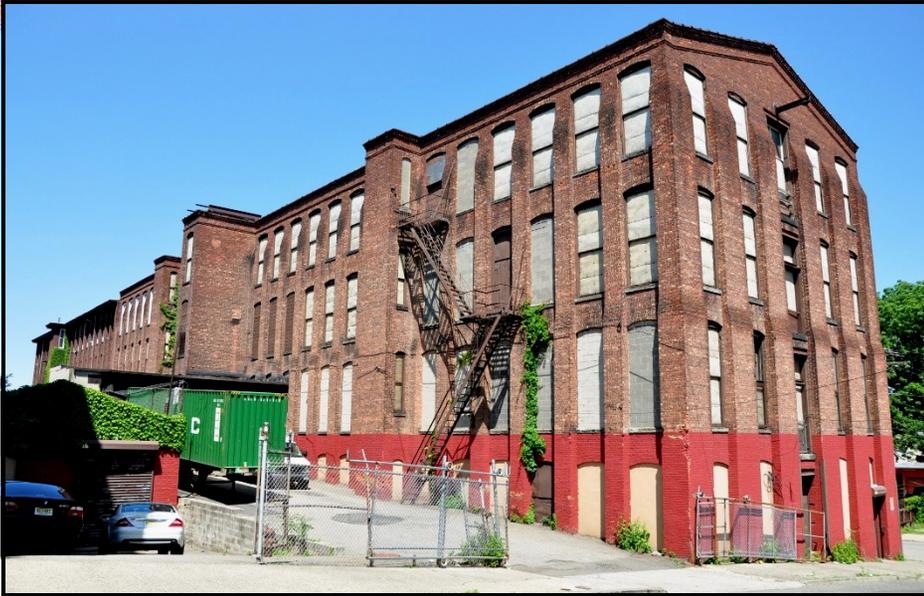
**HALL 5:** oblique view looking SW from Kearny St. showing Totowa Ave. façade.

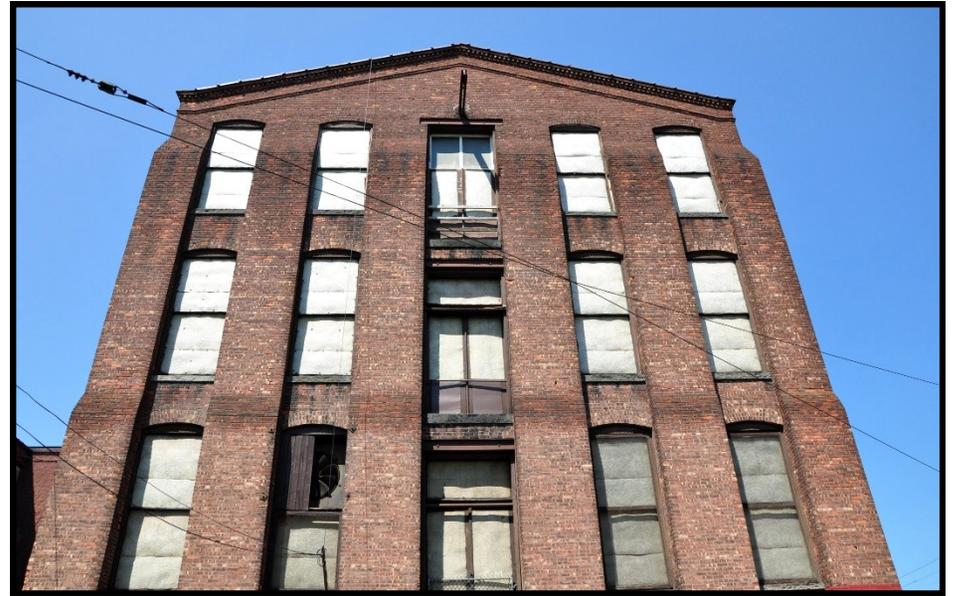
**HALL 6:** oblique view looking NW, showing Kearny St. façade.

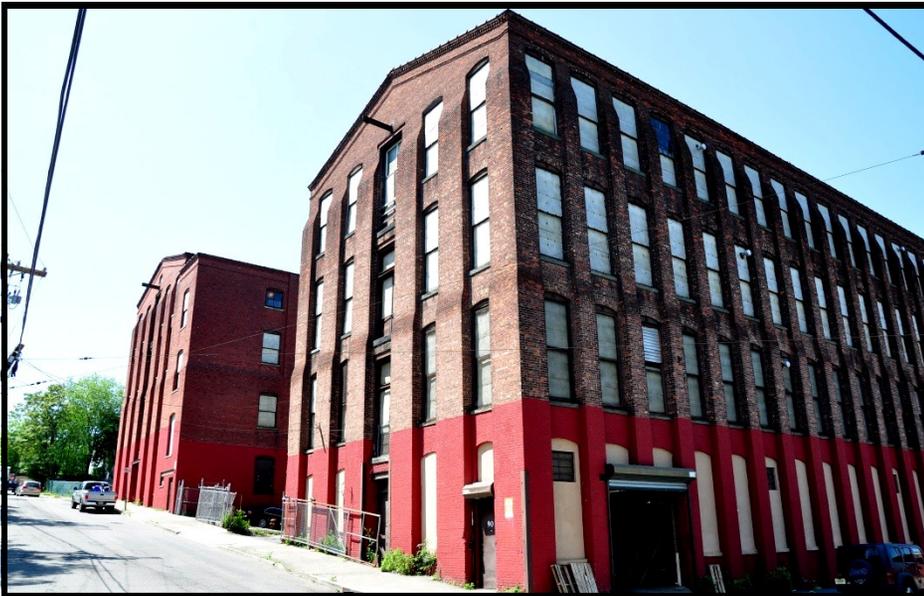
**HALL 7:** Oblique overview looking SW from corner of Fulton and Summer St. (left side), showing East gable ends of the twin Hall mills. The c1899 mill is in the front.

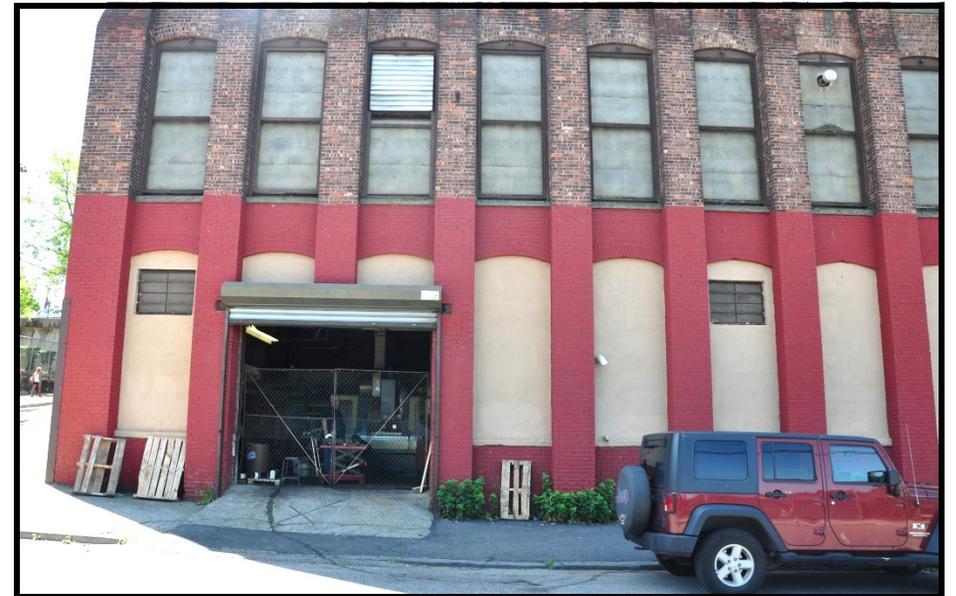
**HALL 8:** detail view of 1899 building, looking S from Fulton St., showing a double bay entrance modification made to accommodate a machine shop tenant.

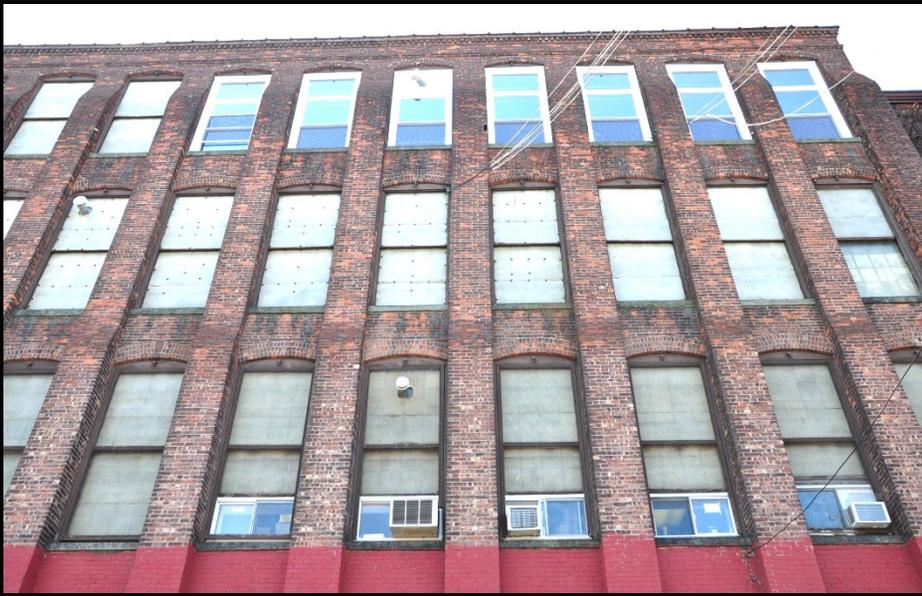
**HALL 9:** detail view of 1899 building, looking S from Fulton St., showing vinyl window replacements made to accommodate tenant reuse.

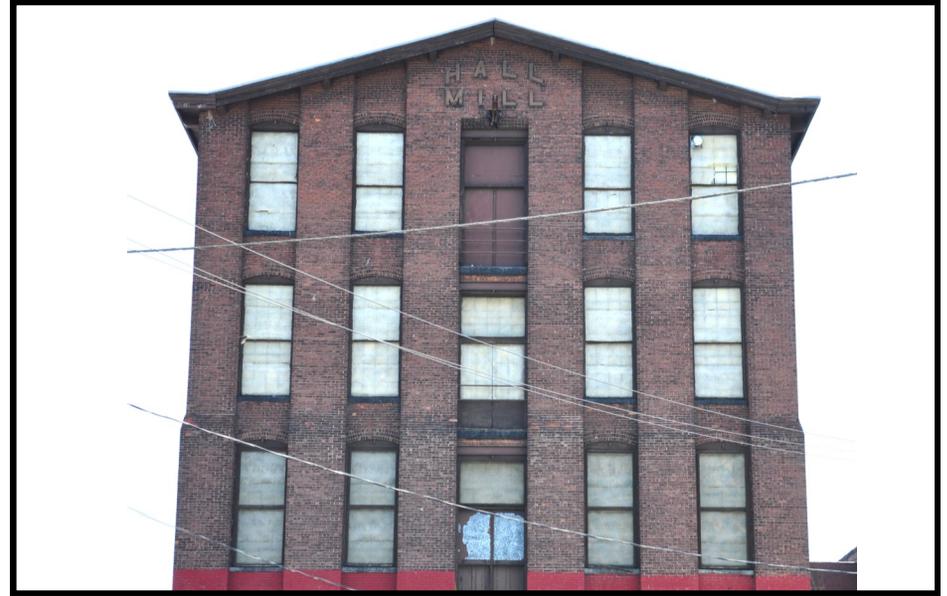
**HALL 10:** detail view of West gable end of the 1899 mill building, looking E from Straight St. The integrity of this façade is clear, including the covered original windows

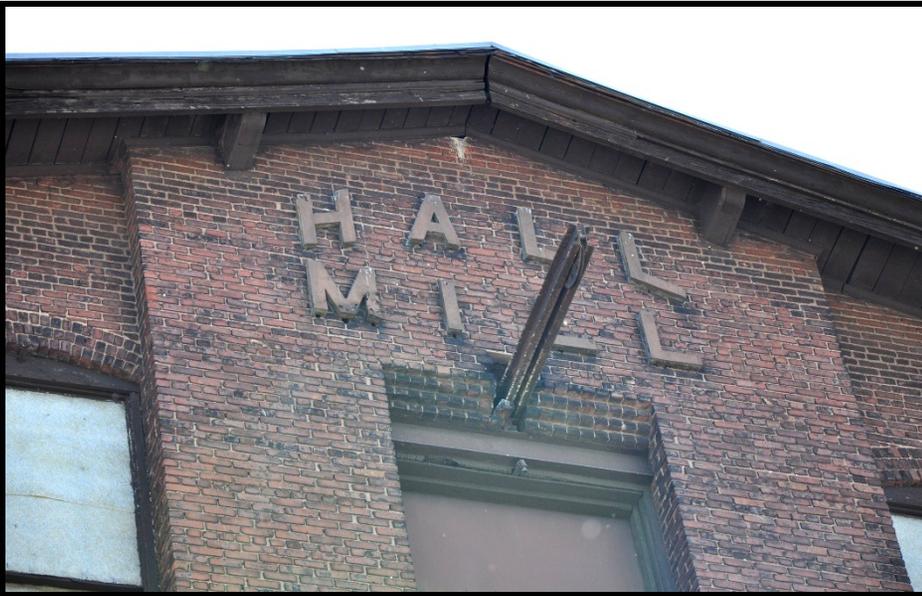
**HALL 11:** close up view of West gable end of the 1899 mill building addition, looking E from Straight St. showing the Hal Mill name in sandstone lettering. The integrity of the open eaves and cornice moldings emphasizes the historic character of the mill addition.

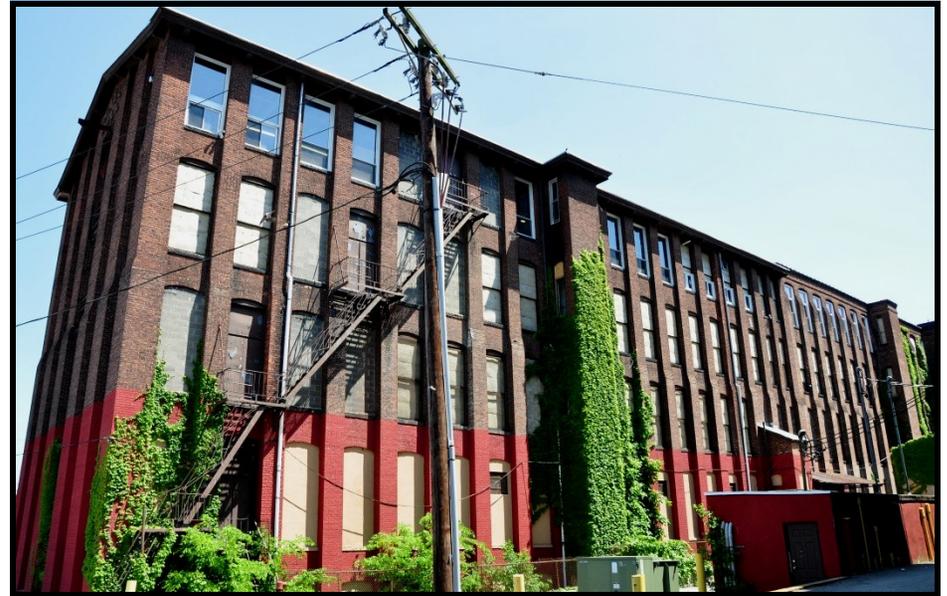
**HALL 12:** Oblique overview looking NE. Note the vinyl replacement windows along the top floor to accommodate tenant reuse.

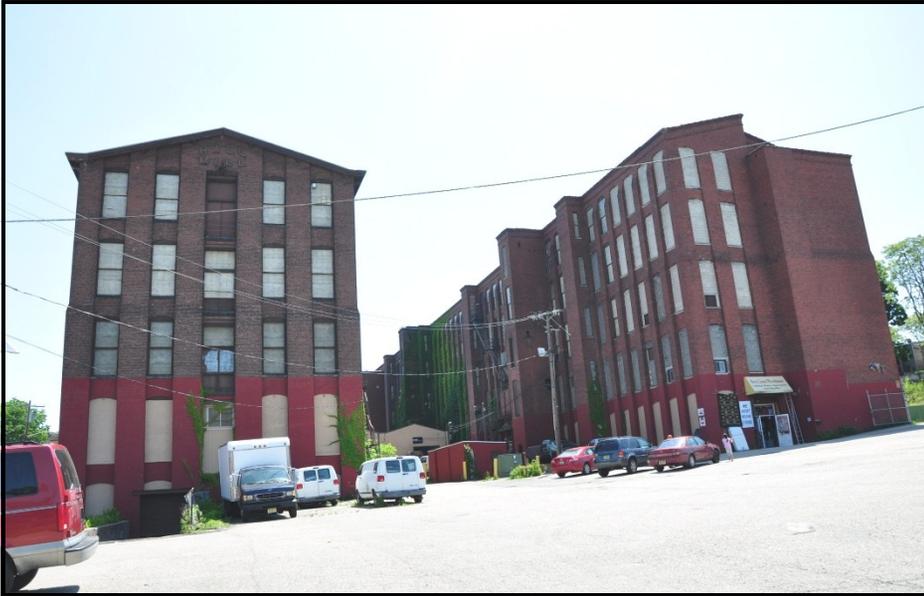
**HALL 13:** oblique overview looking SE from near corner of Fulton and Straight St. showing West gable ends of both Hall Mills. This view offers particular integrity.

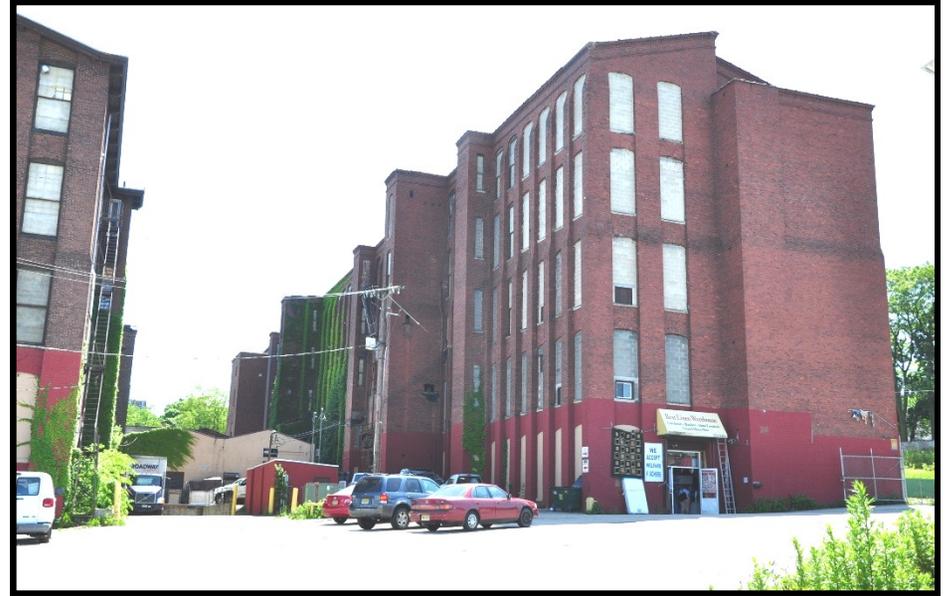
**HALL 14:** oblique view looking SE, showing North side of the 1910s mill building, and view of the boiler house centralized power station at center.

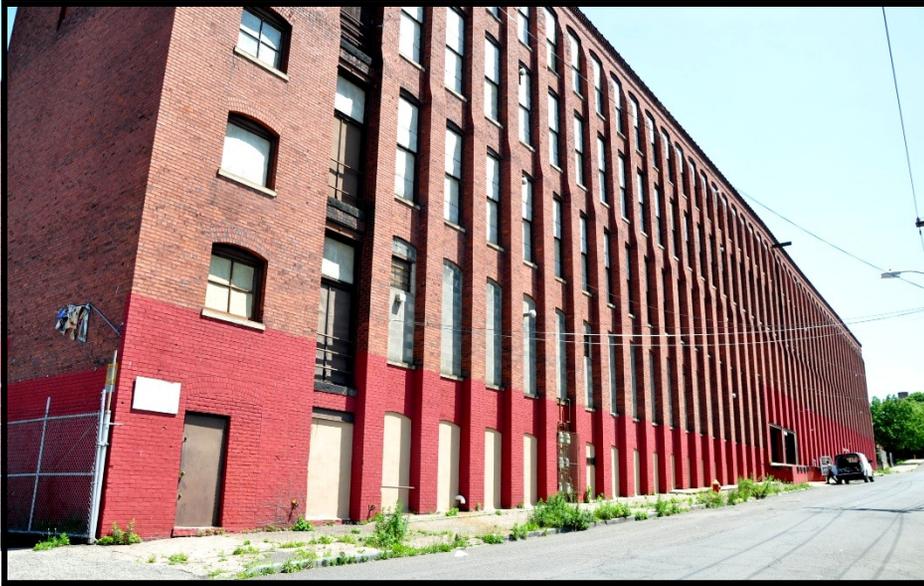
**HALL 15:** oblique overview of South side of 1910s building, looking E along Harrison St., demonstrating the impressive scale and integrity of the site.

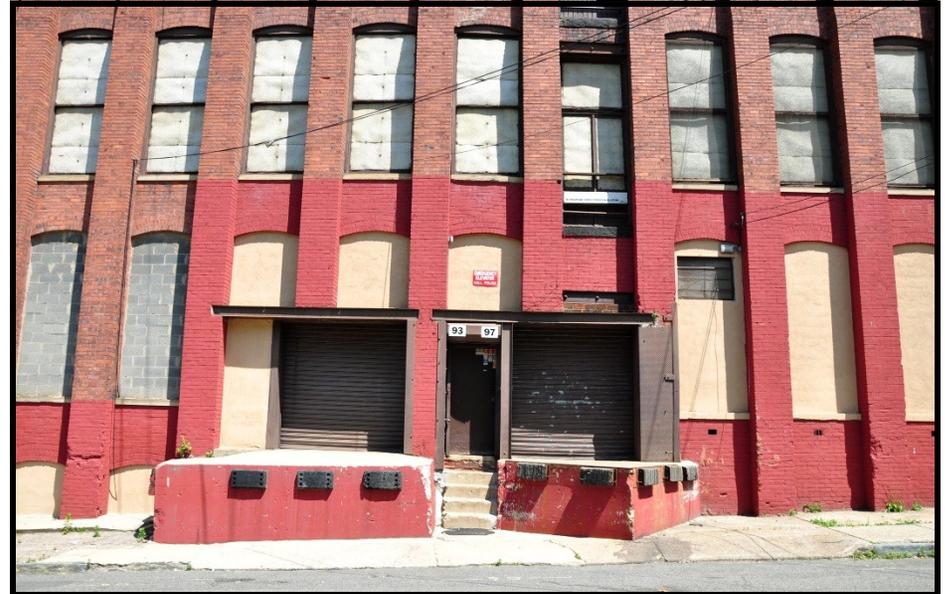
**HALL 16:** detail view of South side of 1910s building, looking N from Harrison St., showing several loading dock and entrance modifications made to accommodate tenant reuse.

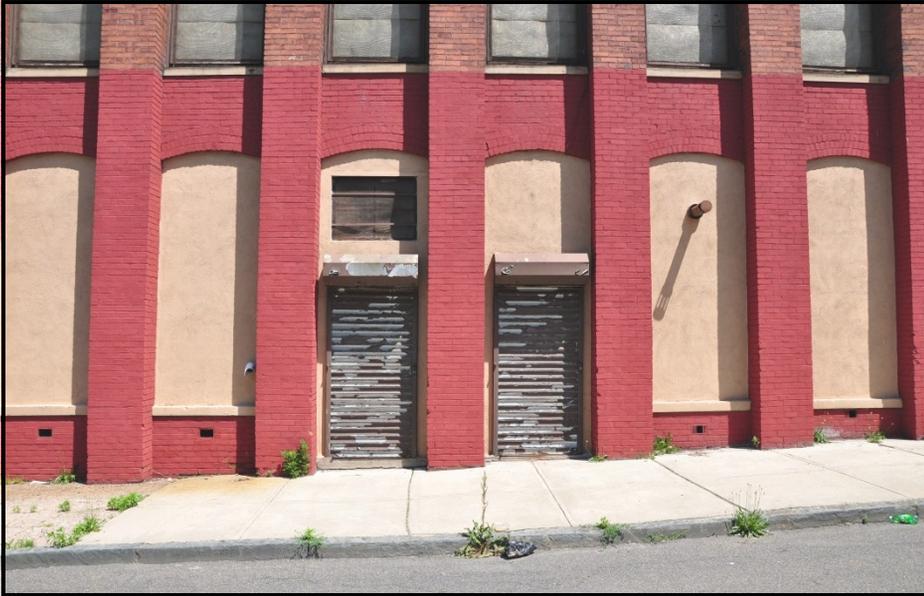
**HALL 17:** detail view of South side of 1910s building, looking N from Harrison St., showing additional entrance modifications made to accommodate tenant reuse. These two entrances are just east of loading docks showing in Hall 16.

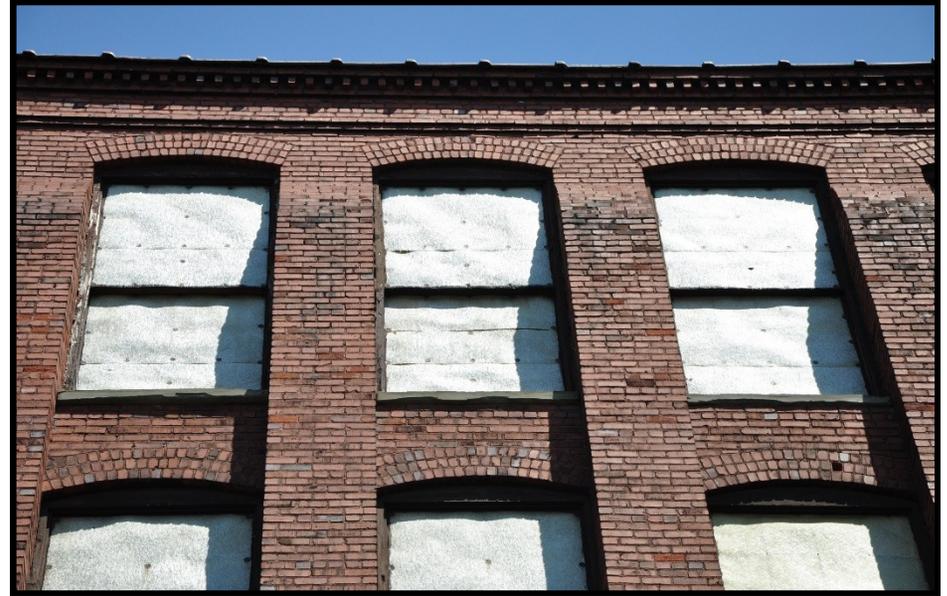
**HALL 18:** detail view of South side of 1910s building, looking N from Harrison St., showing brick dentils, stringcourse detailing, and use of terra cotta coping. Segmental arched windows may be extant behind the white covering material. Integrity is clear.

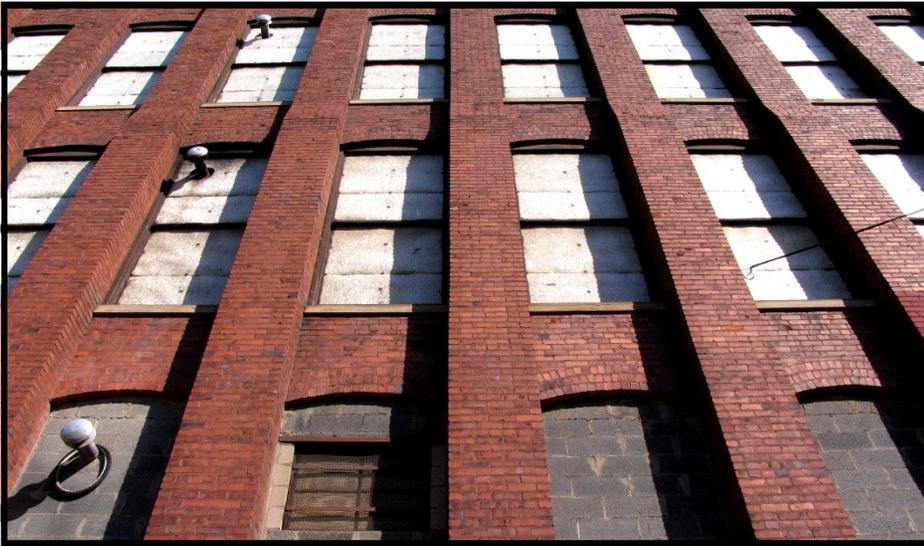
**HALL 19:** detail view of South side of 1910s building, looking N from Harrison St., showing consistent, reversible modifications to window openings (fenestration).

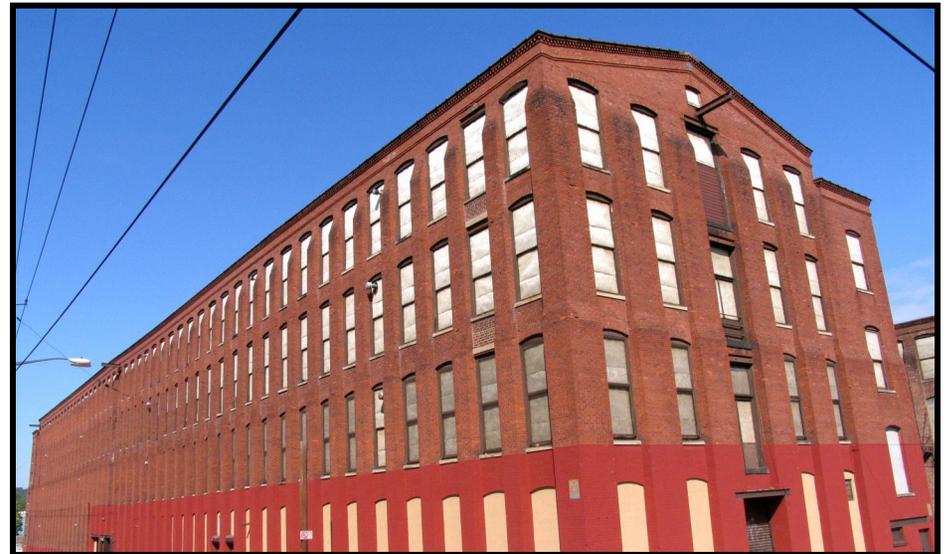
**HALL 20:** Oblique overview looking NW from corner of Harrison and Summer St., showing East gable end and Harrison St. (South) elevation of the 1910s Hall Mill.
