New Jersey Department of Environmental Protection Historic Preservation Office

PROPERTY REPORT

Property Name:Manhattan ShirtOwnership:PrivateAddress:111-237 River STApartment #:ZIP:07501

Survey Name:	Intensive-Level Survey of Paterson Industrial Mills		Property ID:	Page
Principal	Patrick Harshbarger	(Primary Contact)	1465614458

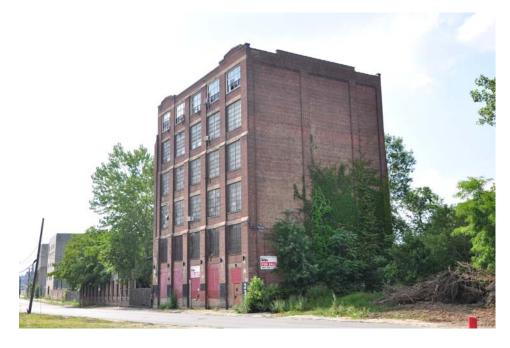
Property Photo:

The Manhattan Shirt Company site consists of a U-plan brick factory building, built circa 1895 with later additions to complete the U, half of which has been heavily altered in a modern rehabilitation. A warehouse, built circa 1920, is located about one block to the northeast. Two large intervening mill buildings and a steam plant, dating to ca. 1880 and ca. 1910, which once provided continuity between the two ends of the site, have been demolished.

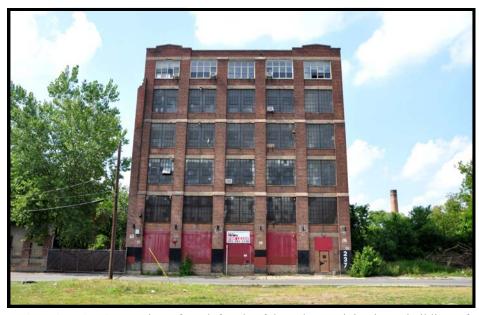
MANHATTAN 1: overview of south façade of the only remaining intact building of the complex, looking north from across River St. Note steel sash windows intact.

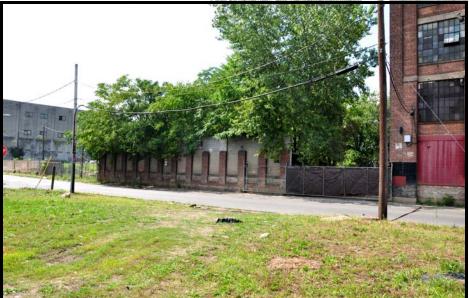
MANHATTAN 3: detail view of demolished area between the two extant buildings of the complex (left and right frame), looking northwest from across River St.

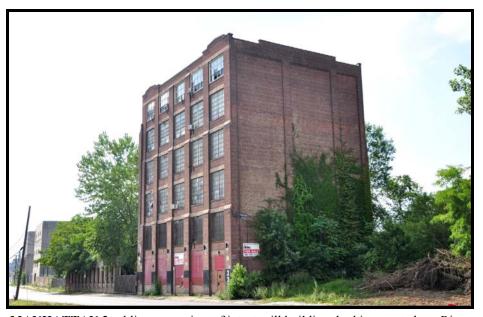
MANHATTAN 2: oblique overview of intact mill building, looking west along River St., showing the demolished areas of the complex on adjacent sides.

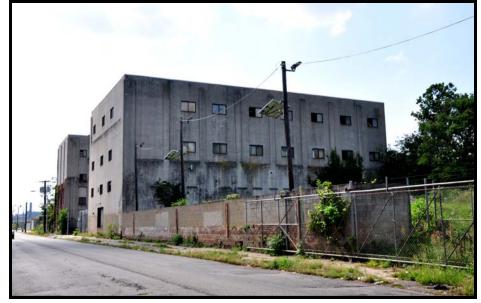
MANHATTAN 4: oblique overview of east and south elevations, looking west along River St. This is the largest mill building of the complex (U-shaped) clearly visible in site development maps. It has been heavily altered and restored.
