PROPERTY REPORT

Property Name: Riverside Silk Mill
Address: 781-821 River ST
Apartment #:
Ownership: Private
ZIP: 07524

Survey Name: Intensive-Level Survey of Paterson Industrial Mills

INDUSTRIAL BUILDING ATTACHMENT

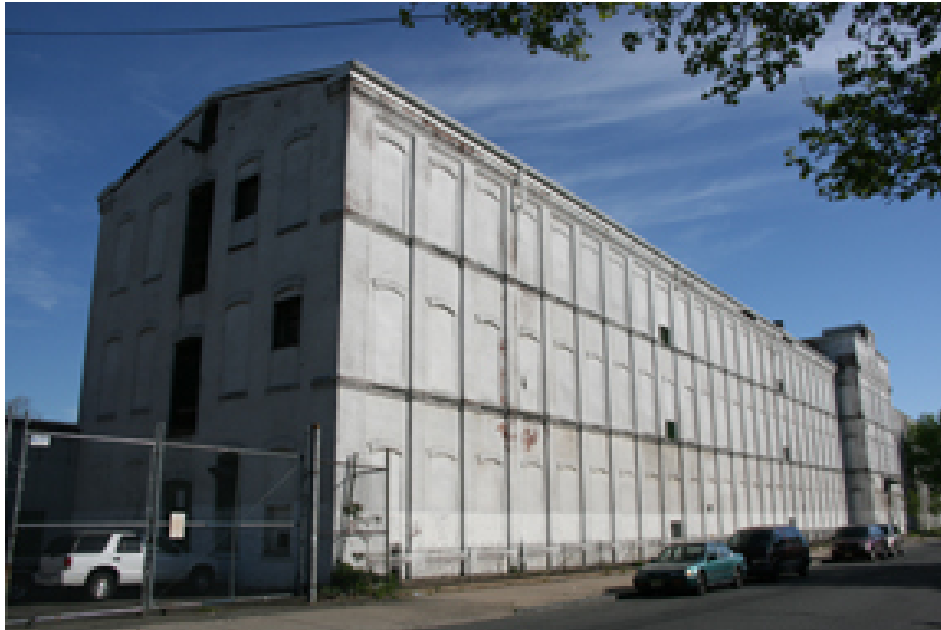
Property Photo:

The Riverside Silk Mill is an industrial complex situated on 3.4 acres. It is comprised of a ca. 1889, 450-ft. brick mill, formerly used for the manufacture of silk ribbons and broad silks. Several non-contributing frame and masonry structures are located to the rear of the mill.

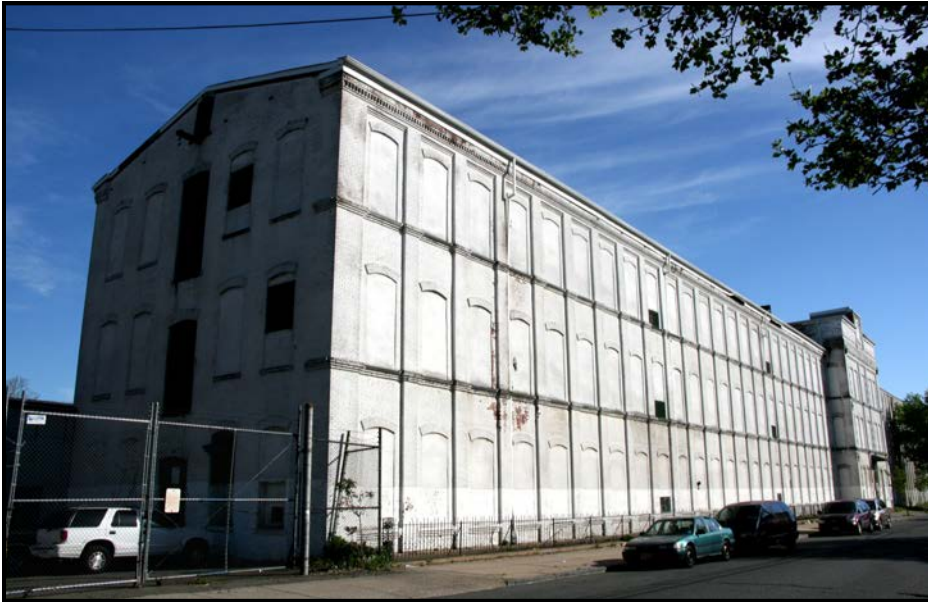
RIVER 1: oblique overview of South façade fronting River St., looking E. Center entrance bay is to far right.

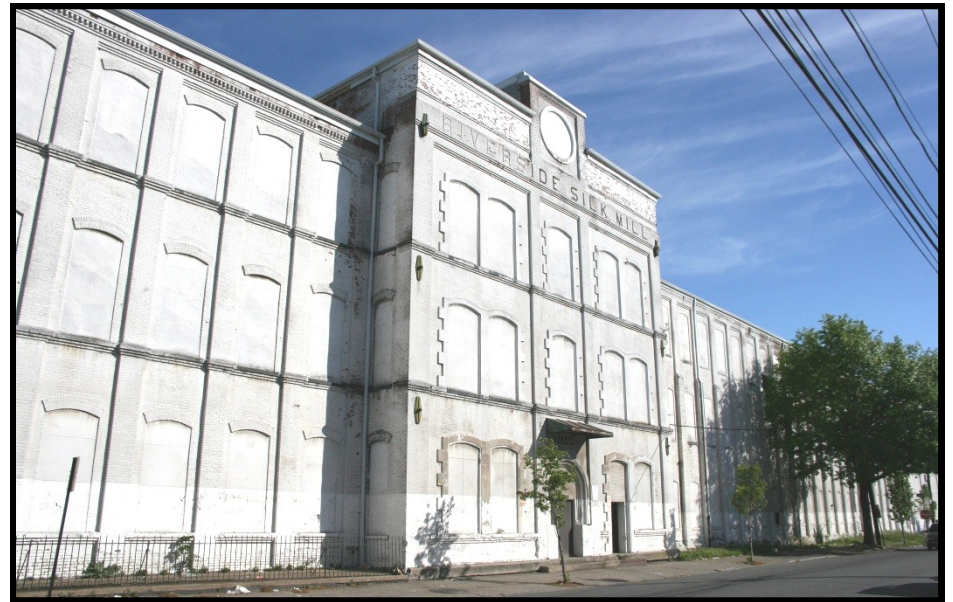
RIVER 2: oblique view of central entrance bay of S façade fronting River St.

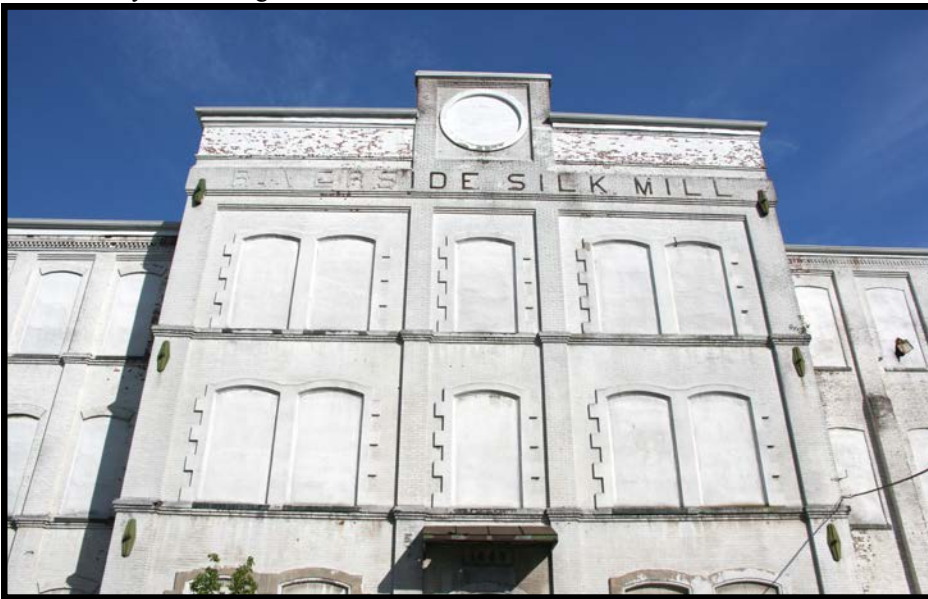
RIVER 3: detail view of central entrance bay of S façade looking N from River St. classicizing embellishments are present, such as the cast stone surrounds and quoining effects on windows, central oculus, faux pilaster columns, and string courses.

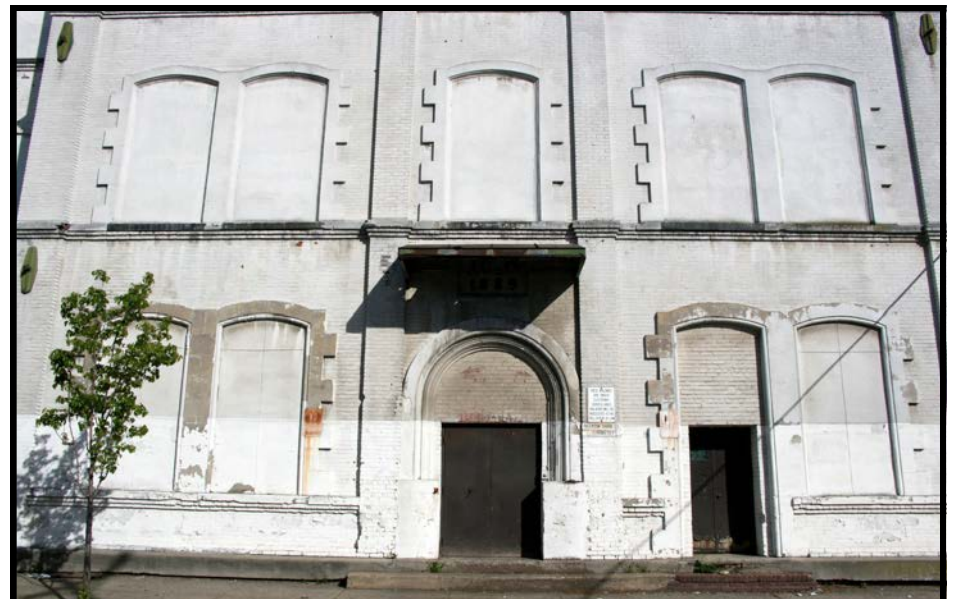
RIVER 4: detail view of central entrance bay of S façade looking N from River St. showing full arched double wide main entrance with marquee.

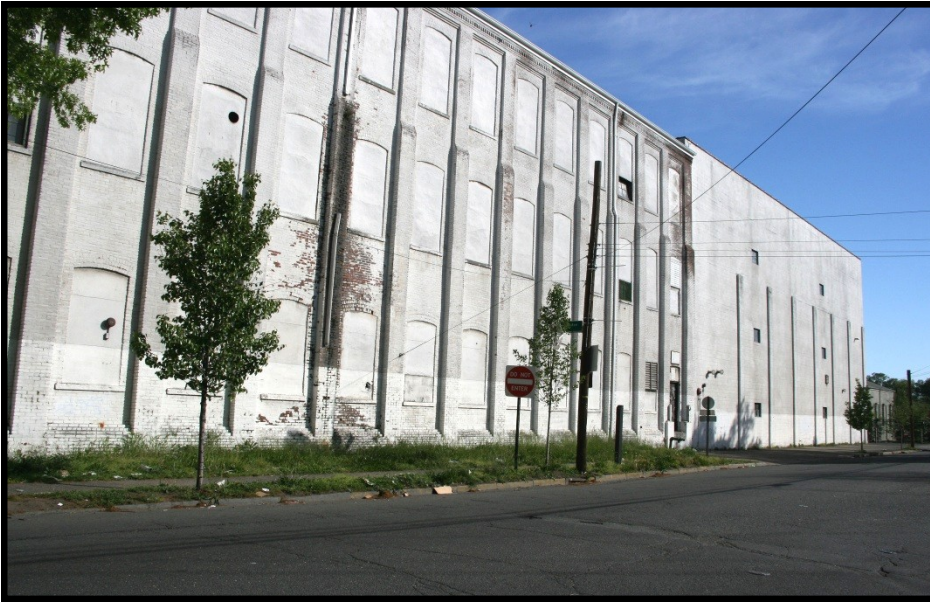
RIVER 5: oblique overview of S façade fronting River St. on the east side of the main entrance. Note the concrete block non-contributing addition.

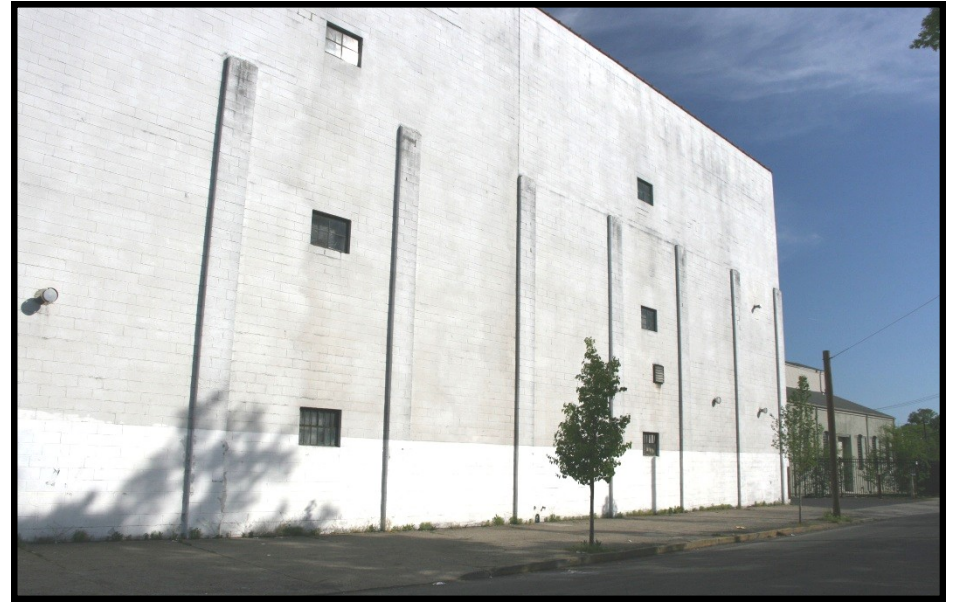
RIVER 6: overview looking NE from River St. of the non-contributing, concrete block addition to the east end of the main building .

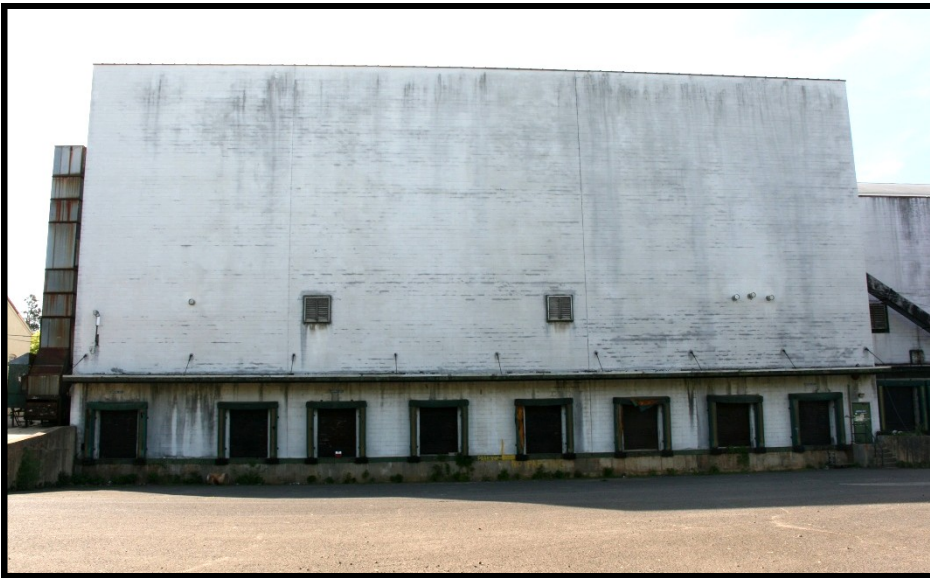
RIVER 7: detail view looking S of the rear of the non-contributing concrete block addition. Note there are eight loading bays and a dock.

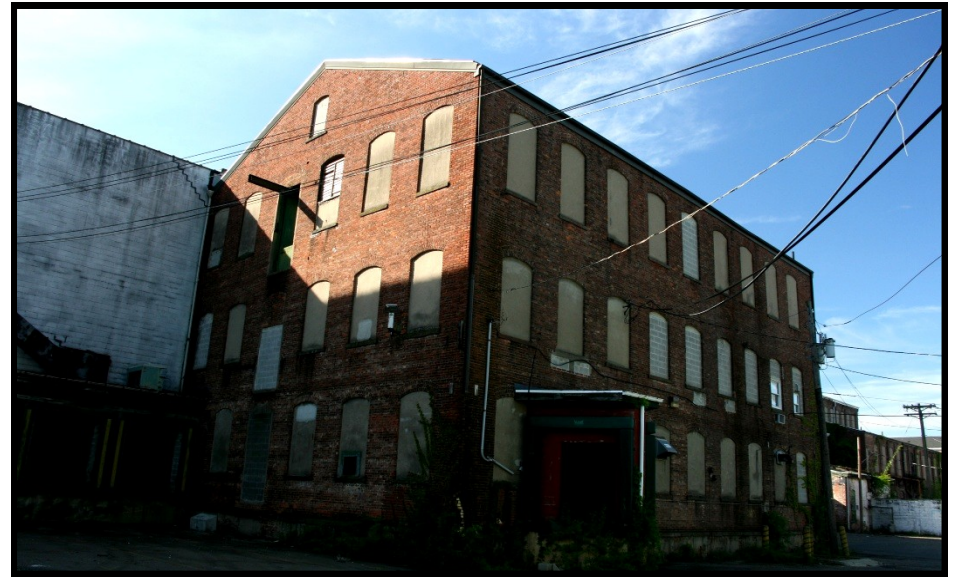
RIVER 8: oblique overview looking SW of a small brick, three story mill building is extant behind the main buildings. Its use is not known.

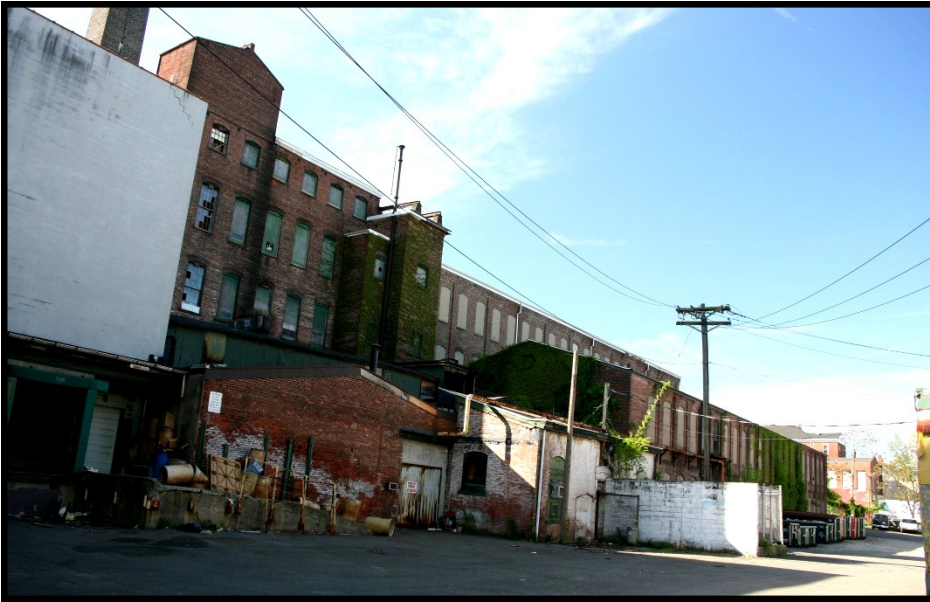
RIVER 9: oblique overview looking SW from rear of complex showing ancillary buildings in foreground and 1900s two story west wing addition in distance.

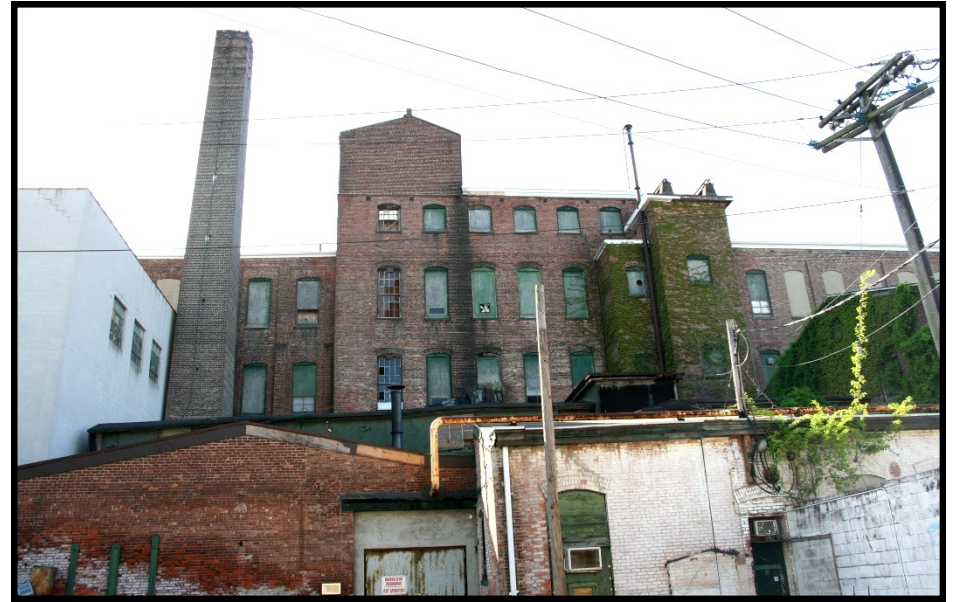
RIVER 10: detail view looking S from rear of complex showing smokestack, boiler house, ancillary buildings and rear of the central section of the main mill.

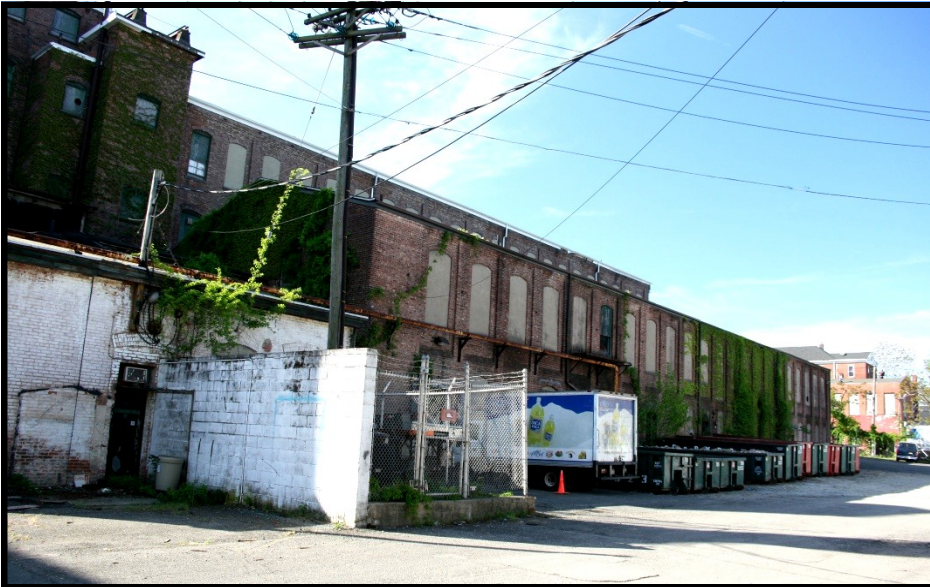
RIVER 11: oblique detail view looking SW from rear of complex showing 1900s addition of a two story west wing behind the 1890s main building.

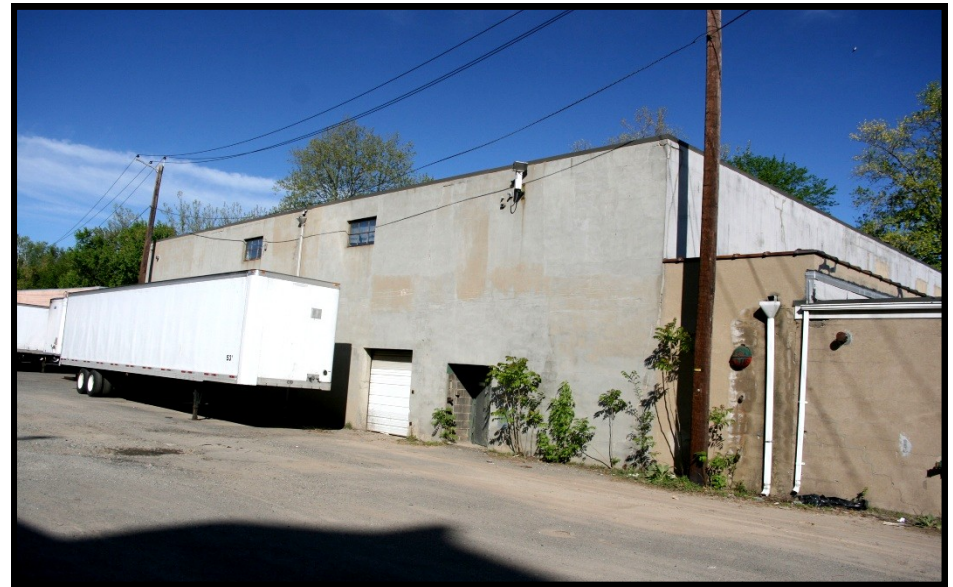
RIVER 12: view looking N from rear of complex of several non contributing ancillary structures along the river bank that defines the rear boundary of the complex.
