### PROPERTY REPORT

**Property Name:** Aronsohn Mill Ownership: Private Address: 245 10th AVE **ZIP:** 07524 Apartment #:

Survey Name: Intensive-Level Survey of Paterson Industrial Mills

# ARONSOHN MILL 245 Tenth Ave., Paterson, NJ B 3204 L 02 Site Development Maps 1877, 1884, 1899, 1915

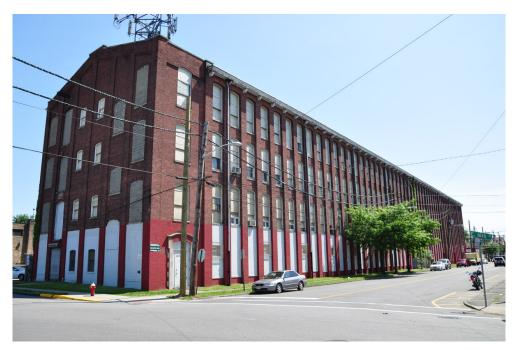
#### **Property Photo:**

The Aronsohn Mill is an industrial complex situated on 1.6 acres containing two ca. 1908 brick buildings formerly used for silk manufacturing and currently occupied by multiple commercial/industrial tenants. The main building is a four-story, brick and heavy-timber framed mill arranged east to west along 10th Avenue with a boiler house/power plant behind it.

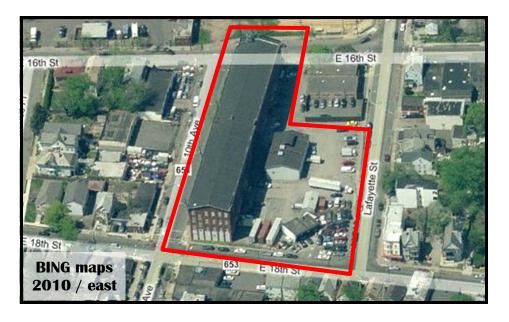
ARONSOHN MILL 245 Tenth Ave., Paterson, NJ B 3204 L 02 Site Development Maps, 1931, 2006, 2010

In 1931, the Sanborn Insurance Company noted on its map that the mill was used for silk warping, quilling and weaving on all of its floors with an office located on the first floor. The mill was supplying its own electric power with two boilers and electric dynamos in the powerhouse.

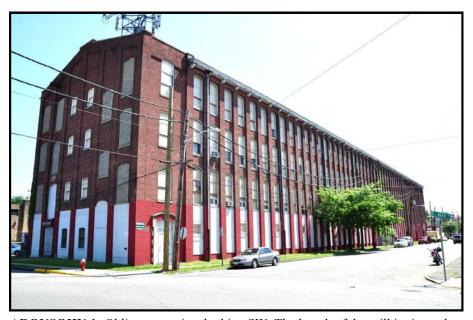
**ARONSOHN 1:** Oblique overview looking SW. The length of the mill is situated along Tenth Ave. and the East gable end faces 18<sup>th</sup> St.

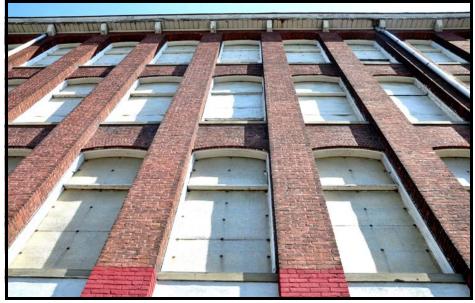
**ARONSOHN 3:** Detail view looking S from Tenth Ave. sidewalk. Note slight pilasters between each window, open eaves, segmental arched, double hung window frames are intact, but lights that have been replaced with an opaque infill material.

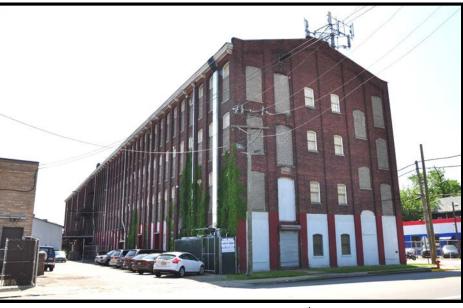
**ARONSOHN 2:** Oblique overview looking NW from 18<sup>th</sup> St., showing the East gable end and the rear of the mill.

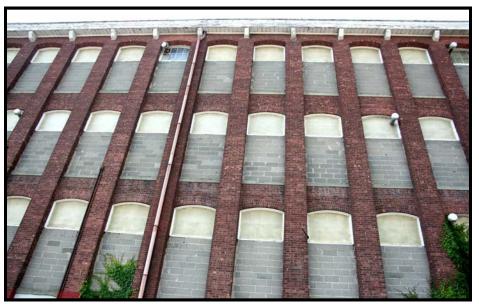
**ARONSOHN 4:** Detail view looking S from Tenth Ave. sidewalk. Note double hung window frames are intact, but lights have been replaced consistently with concrete block infill.

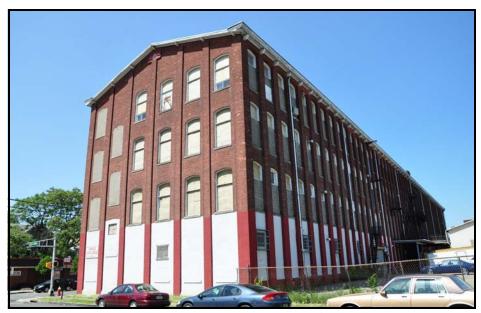
**ARONSOHN 5:** Oblique overview looking NW from 16<sup>th</sup> St., showing the West gable end and the rear of the mill.

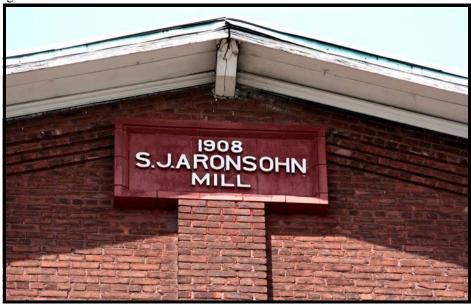
**ARONSOHN 7:** Close up view of cast stone entablature name plate mounted just under the roof peak of the West gable end of the mill.

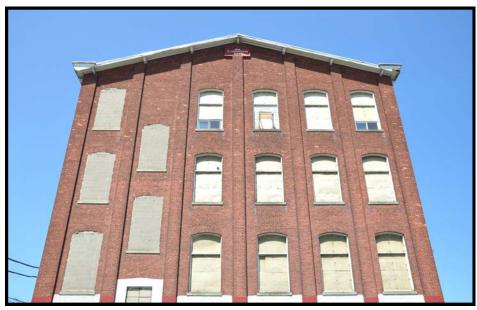
**ARONSOHN 6:** Detail view of West gable end, looking east from 16<sup>th</sup> St. Note entablature name plate mounted just under the peak at center.

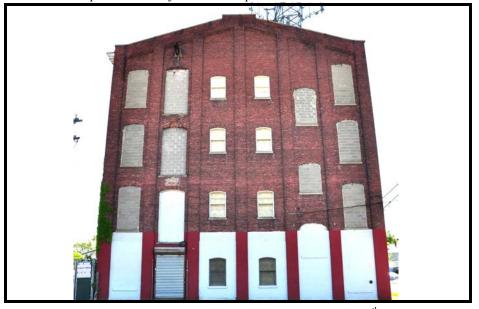
**ARONSOHN 8:** Overview of East gable end, looking west from 18<sup>th</sup> St. Note the modifications to windows and roll up door entrance.

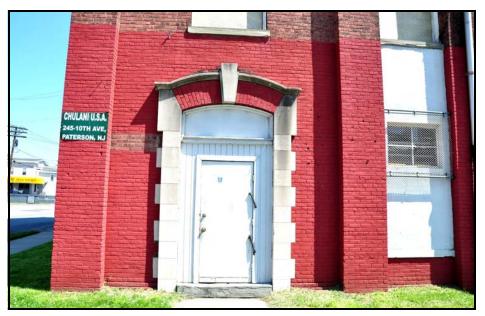
**ARONSOHN 9:** Detail view of east entrance on North side. Note the quioning and semi segmental hooded pediment with exaggerated keystone, which are classicizing elements that are indicative of F.W. Wentworth's design of the building.

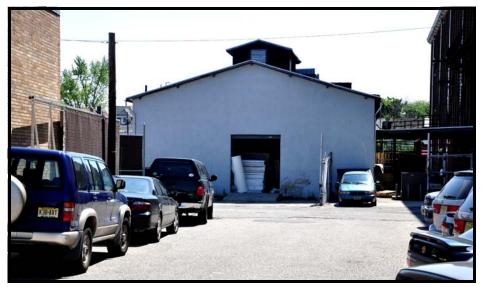
**ARONSOHN 11:** View of boiler house building behind the mill, looking west. The building is historically the only ancillary building on the complex, and remains extant today.

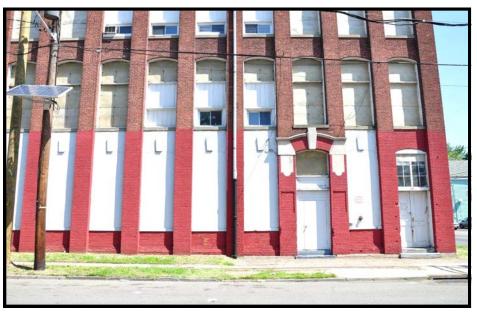
**ARONSOHN 10:** Detail view of west entrance on North side. Note the semi segmental hooded pediment with exaggerated keystone, which are classicizing elements that are indicative of F.W. Wentworth's design of the building.
