PROPERTY REPORT

Property Name: Hall Mills
Address: 94 Fulton ST
Apartment #:
Ownership: Private
ZIP: 07501

Survey Name: Intensive-Level Survey of Paterson Industrial Mills

I.A. HALL MILLS

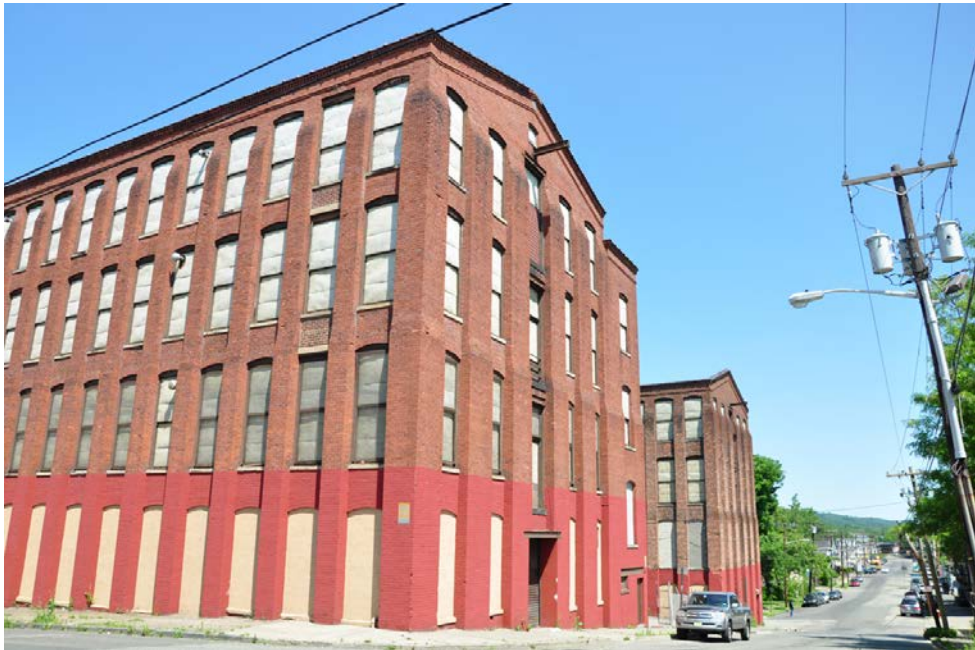
Property Photo:

The Hall Mill is situated on 1.5 acres; it contains two 4-story tenant mills, each measuring approximately 340 feet. The northern mill parallels Fulton Street and was constructed ca. 1899. The southern mill, fronting Harrison Street, was constructed between 1899 and 1915, at which time the earlier mill was expanded to its current dimensions.

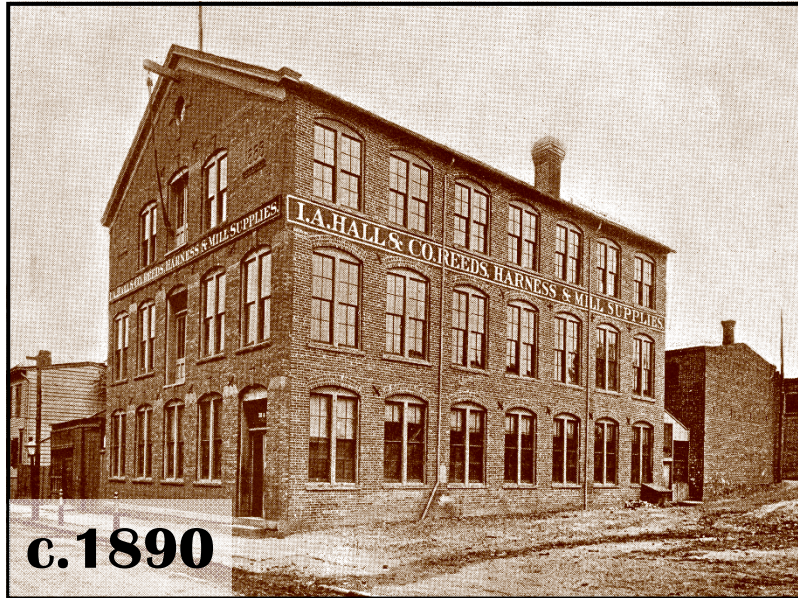
HALL 1: Isaac Hall's mill on Division St. c.1890. Hall developed a campus in that area where he expanded his mill supply business as his products became widely known. He invested profits by erecting a large tenant mill on Fulton St. c.1899,

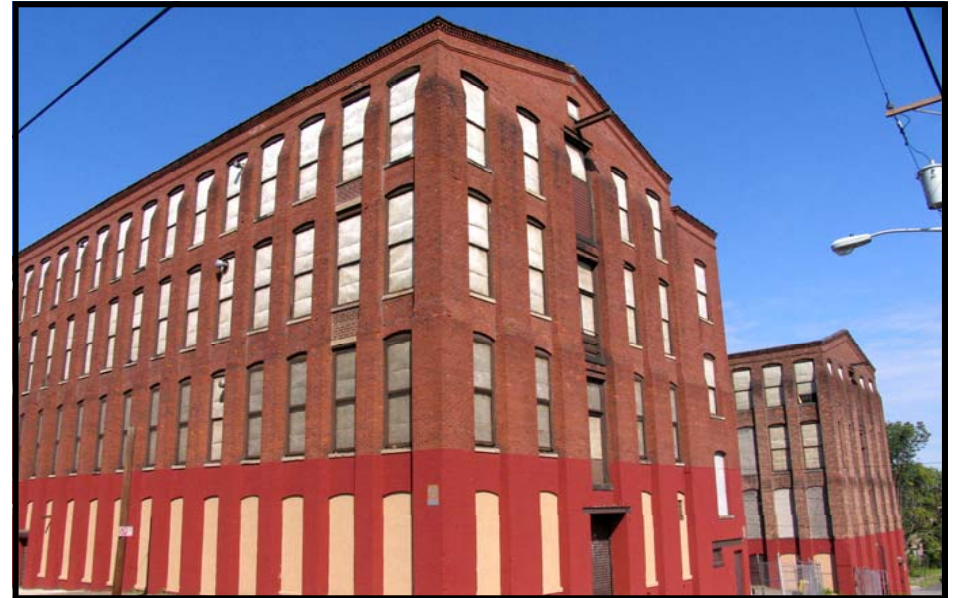
HALL 2: Oblique overview looking NW from corner of Harrison and Summer St., showing East gable ends of the twin Hall mills.

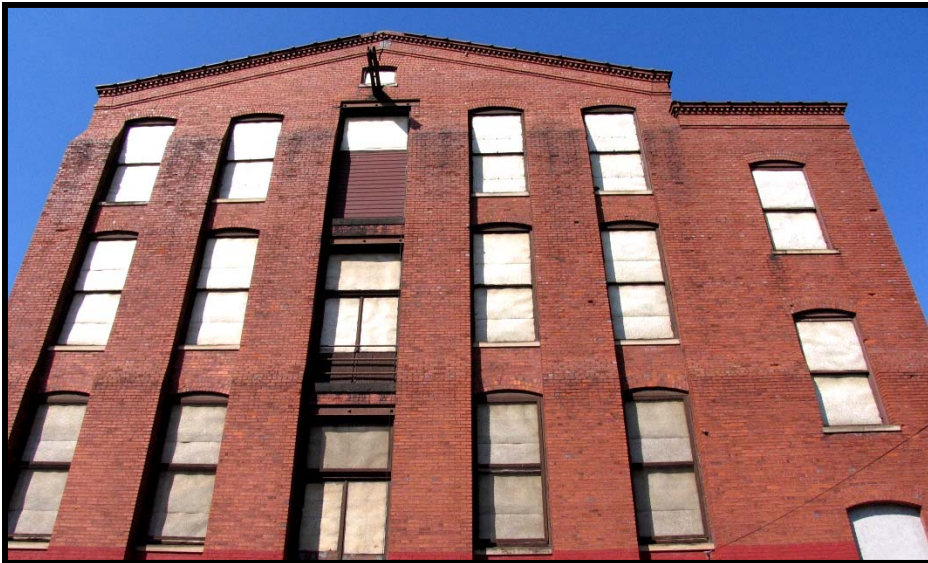
HALL 3: Detail view of 1910s building east gable end, looking W.

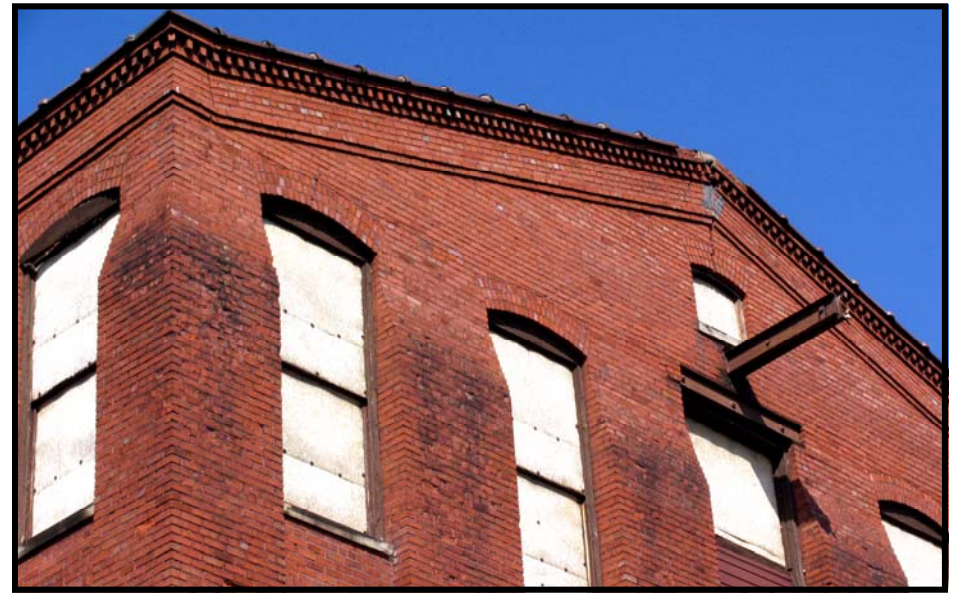
HALL 4: close up view of 1910s building east gable end, looking NW. Details of interest are clearly shown: meticulous brick corbelling and running course work of the closed eaves, the terra cotta coping, and the gradual-stepped buttressed pilasters.

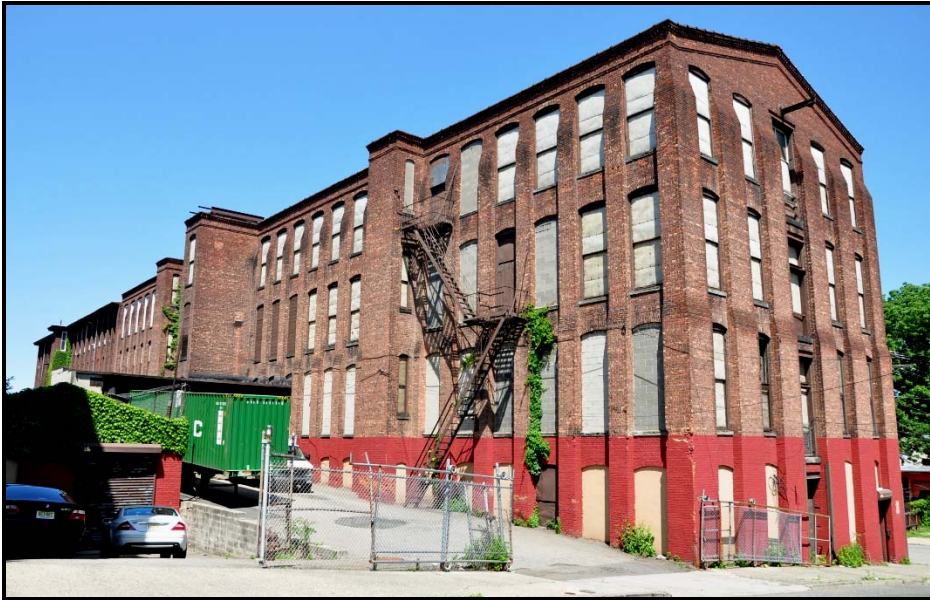
HALL 5: oblique view looking NW from Summer St. showing South façade of the North mill.

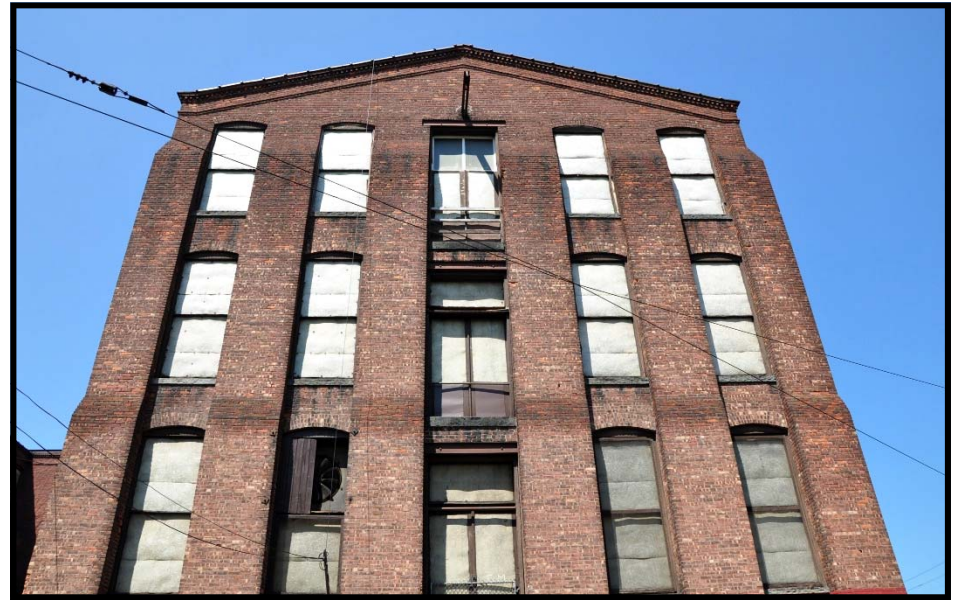
HALL 6: oblique view looking West, showing Summer St. façade.

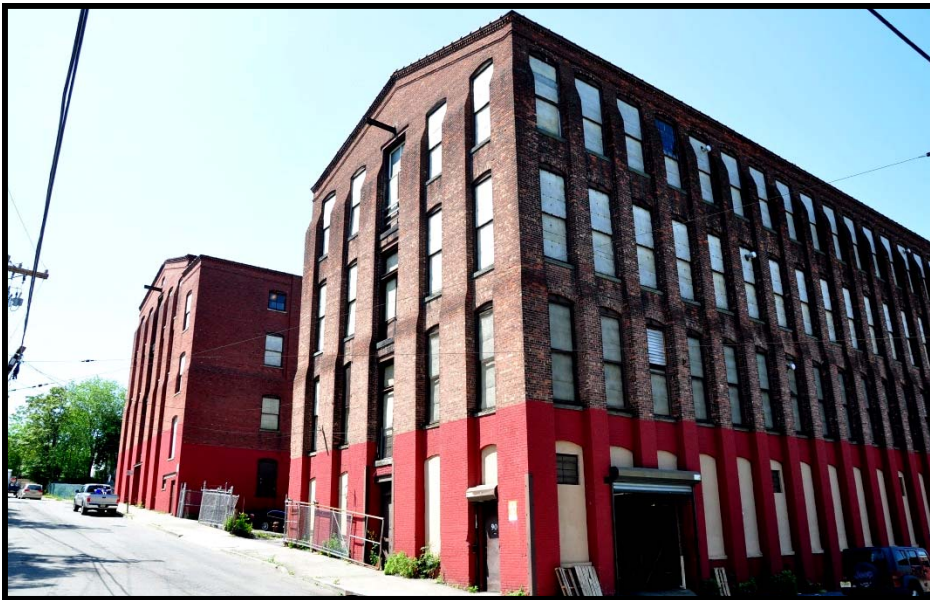
HALL 7: Oblique overview looking SW from corner of Fulton and Summer St. (left side), showing East gable ends of the twin Hall mills. The c1899 mill is in the front.

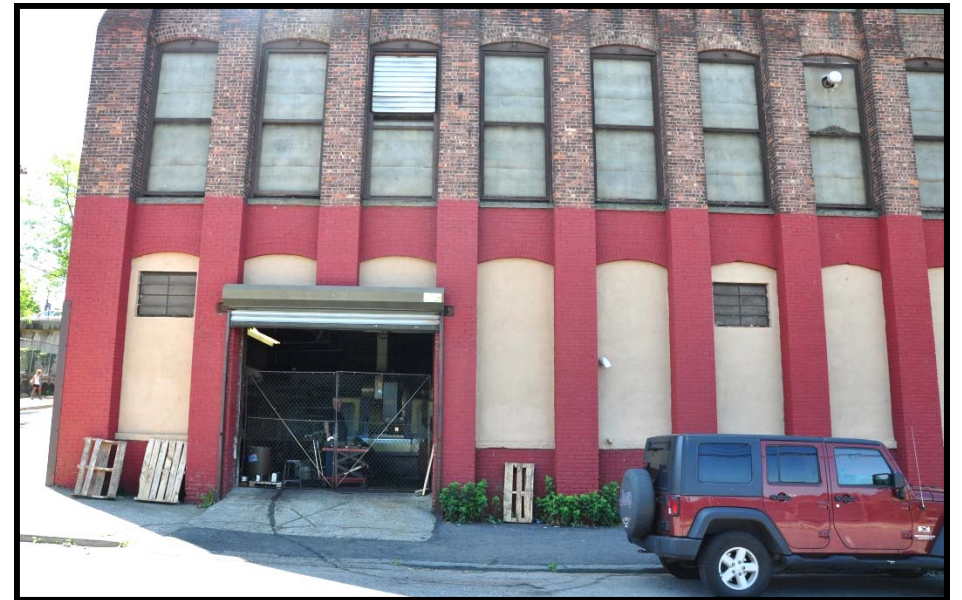
HALL 8: detail view of 1899 building, looking S from Fulton St., showing a double bay entrance modification made to accommodate a machine shop tenant.

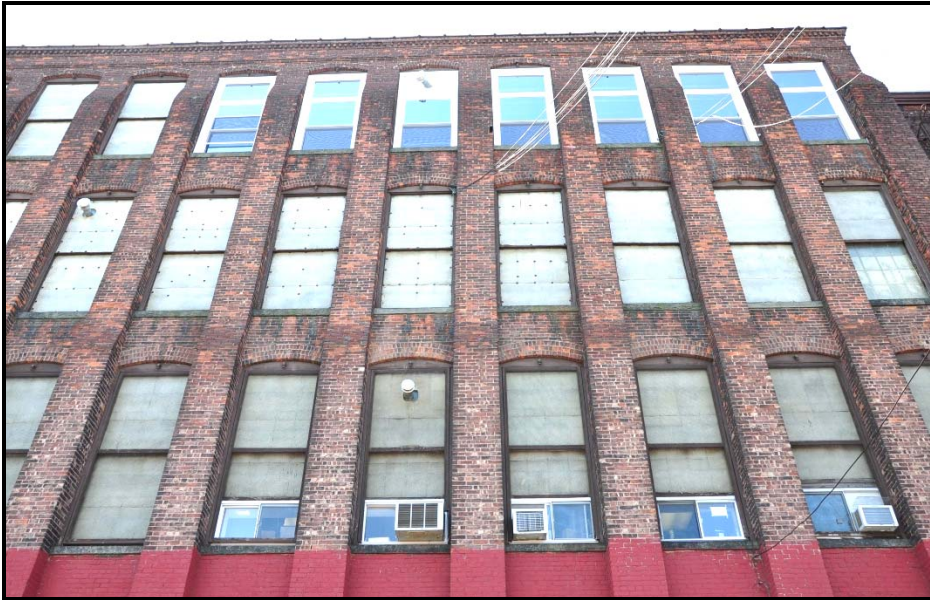
HALL 9: detail view of 1899 building, looking S from Fulton St., showing vinyl window replacements made to accommodate tenant reuse.

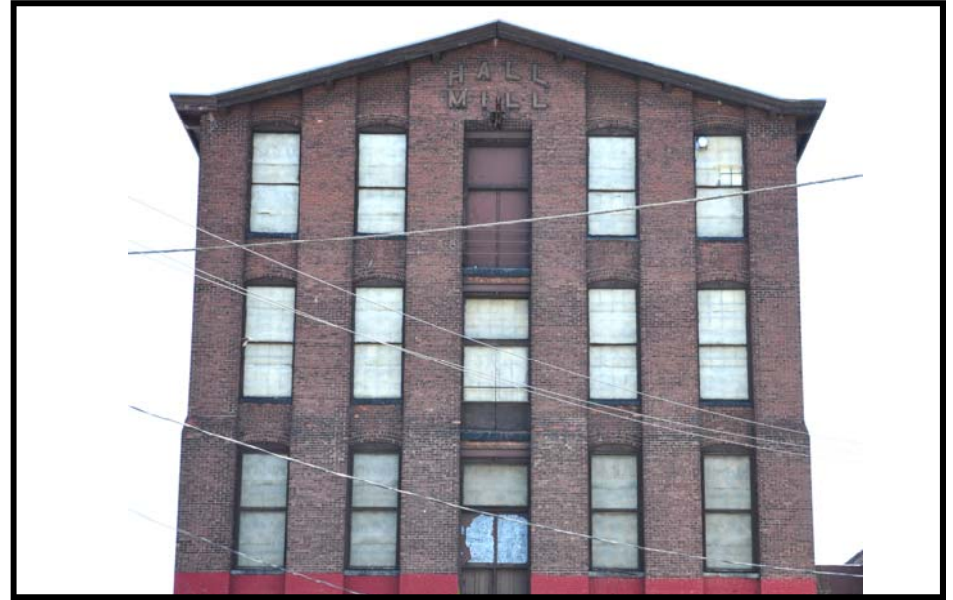
HALL 10: detail view of West gable end of the 1899 mill building, looking E from Straight St. The integrity of this façade is clear, including the covered original windows

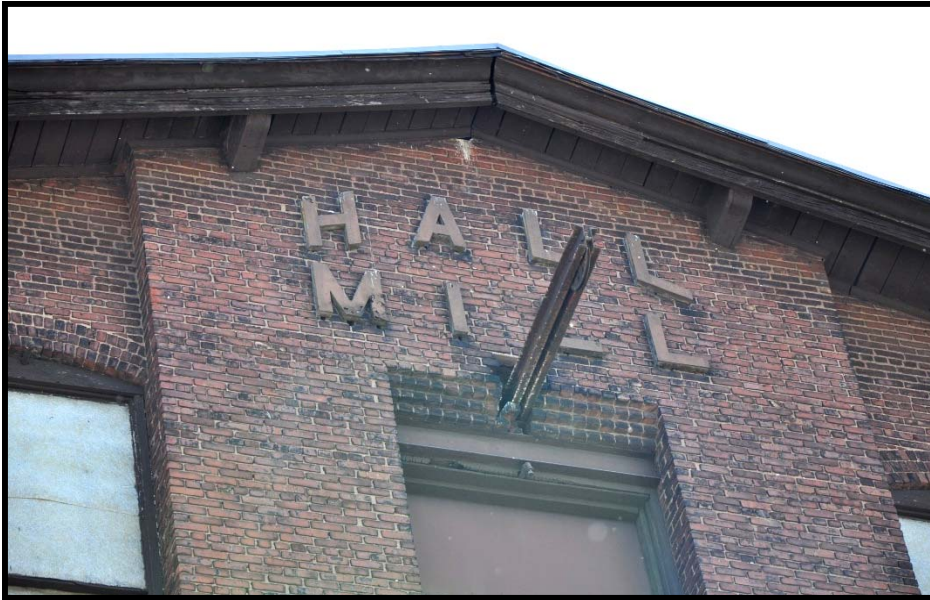
HALL 11: close up view of West gable end of the 1899 mill building addition, looking E from Straight St. showing the Hal Mill name in sandstone lettering. The integrity of the open eaves and cornice moldings emphasizes the historic character of the mill addition.

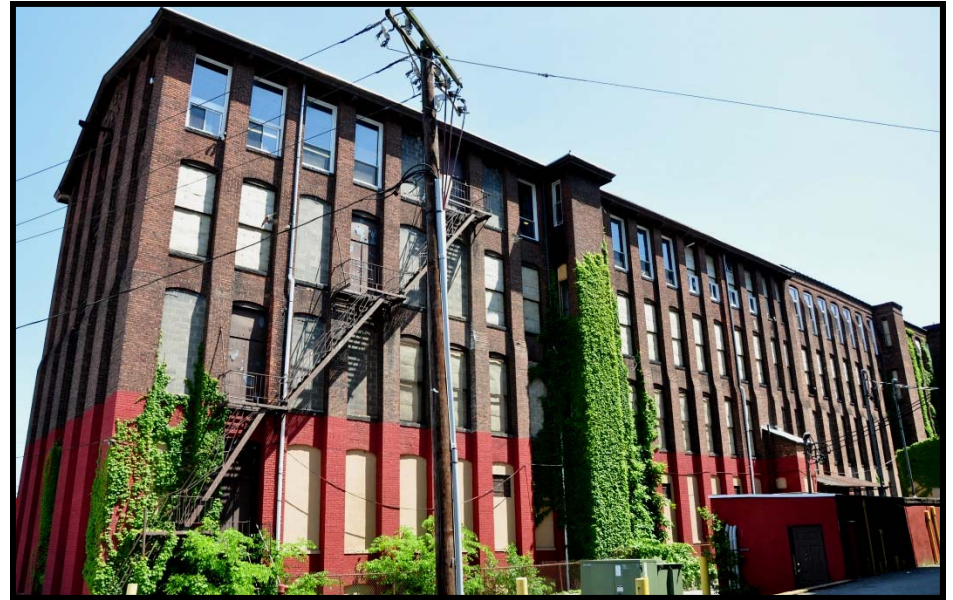
HALL 12: Oblique overview looking NE. Note the vinyl replacement windows along the top floor to accommodate tenant reuse.

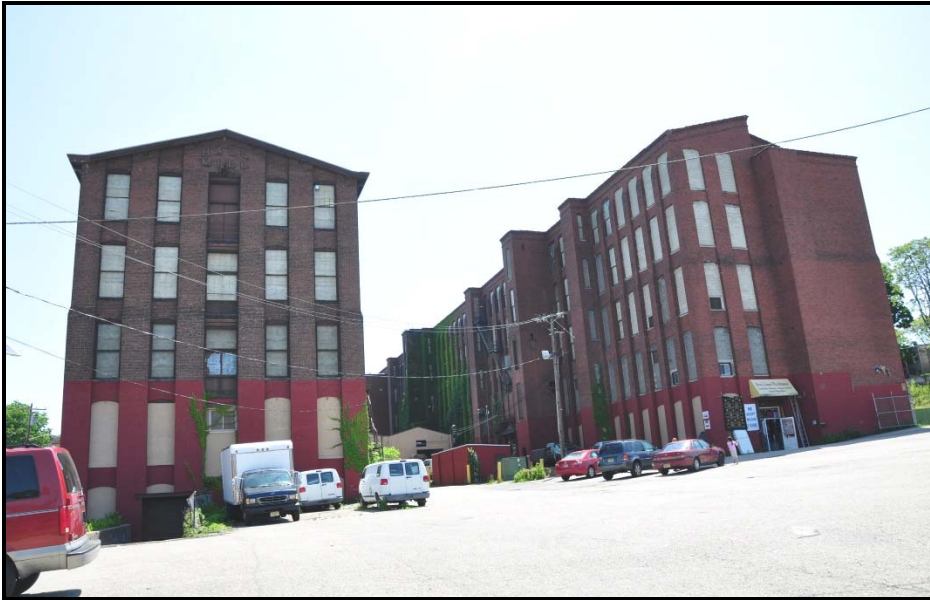
HALL 13: oblique overview looking SE from near corner of Fulton and Straight St. showing West gable ends of both Hall Mills. This view offers particular integrity.

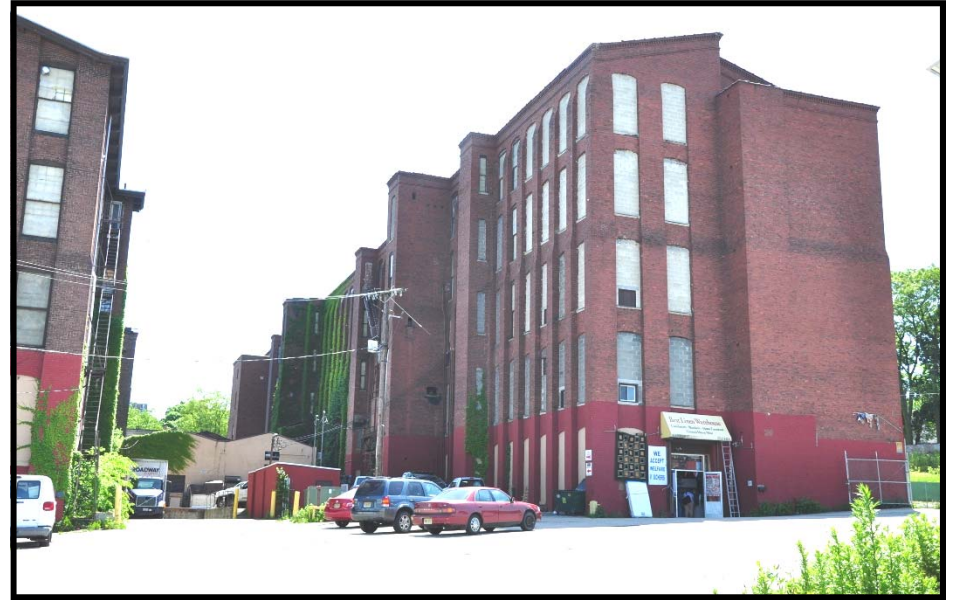
HALL 14: oblique view looking SE, showing North side of the 1910s mill building, and view of the boiler house centralized power station at center.

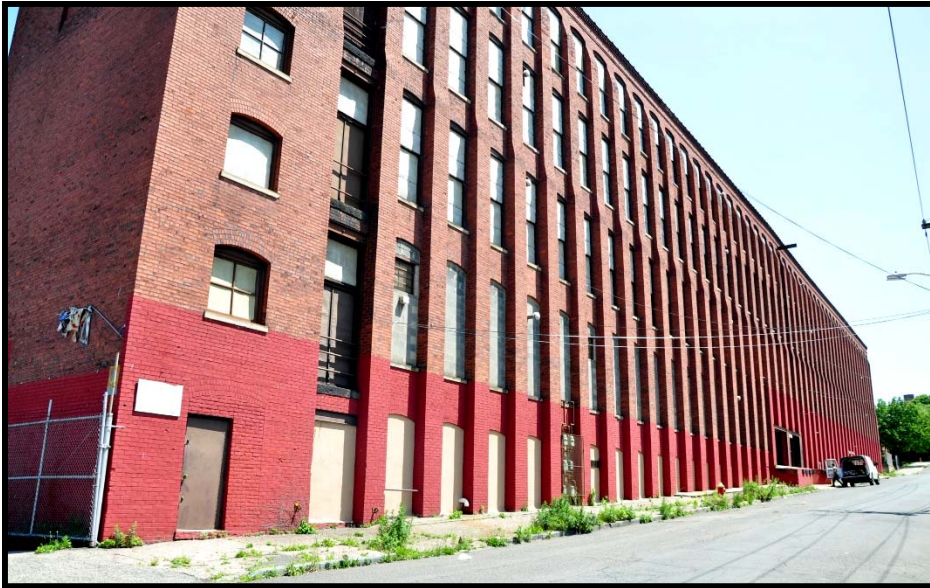
HALL 15: oblique overview of South side of 1910s building, looking E along Harrison St., demonstrating the impressive scale and integrity of the site.

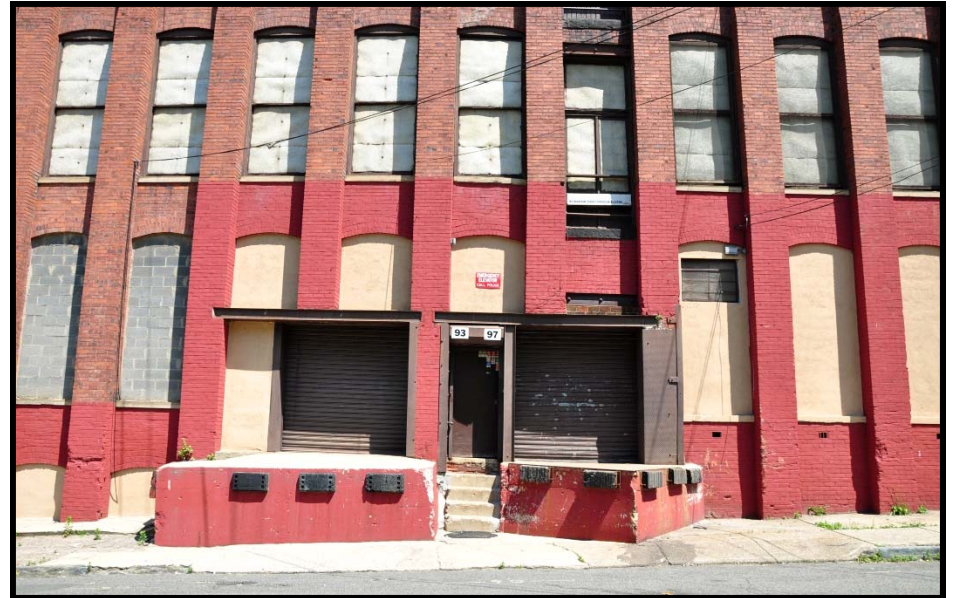
HALL 16: detail view of South side of 1910s building, looking N from Harrison St., showing several loading dock and entrance modifications made to accommodate tenant reuse.

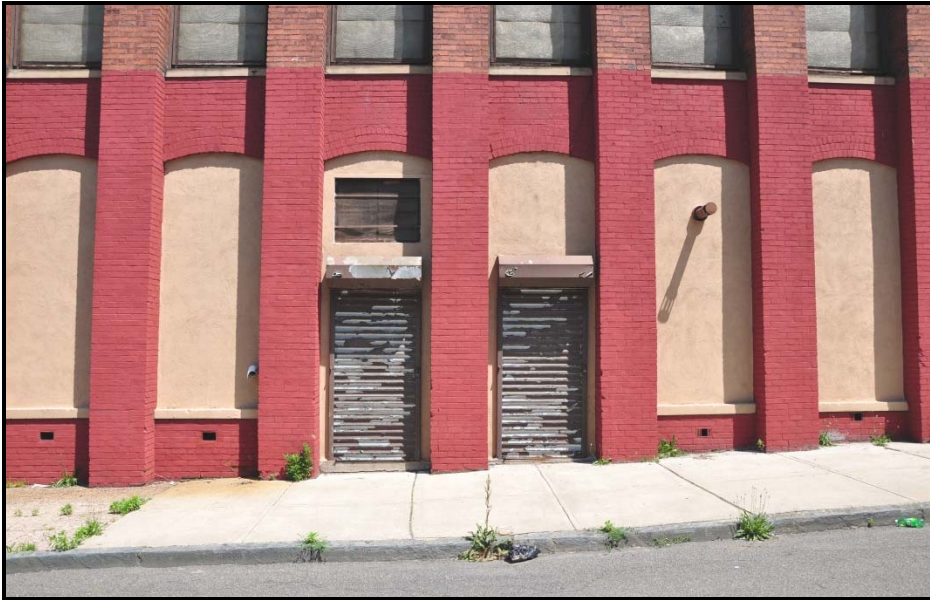
HALL 17: detail view of South side of 1910s building, looking N from Harrison St., showing additional entrance modifications made to accommodate tenant reuse. These two entrances are just east of loading docks showing in Hall 16.

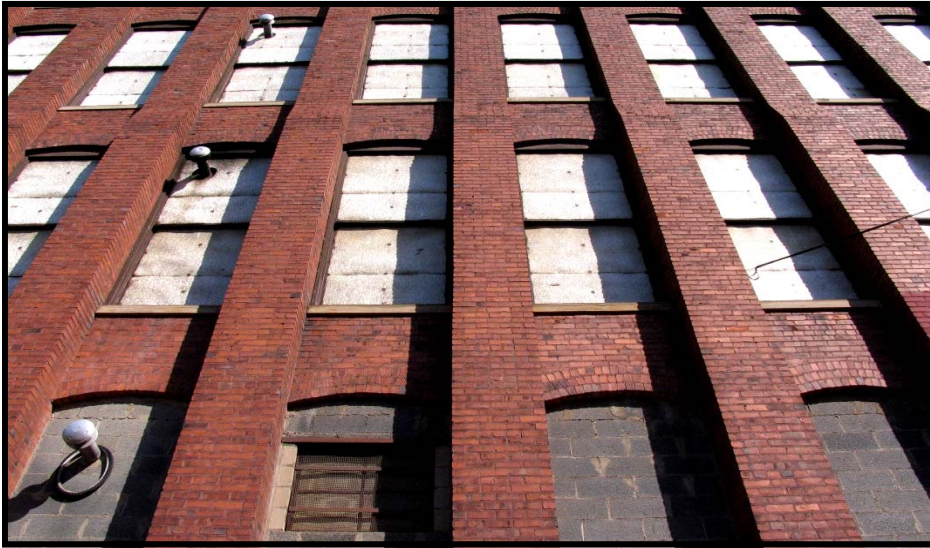
HALL 19: detail view of South side of 1910s building, looking N from Harrison St., showing consistent, reversible modifications to window openings (fenestration).

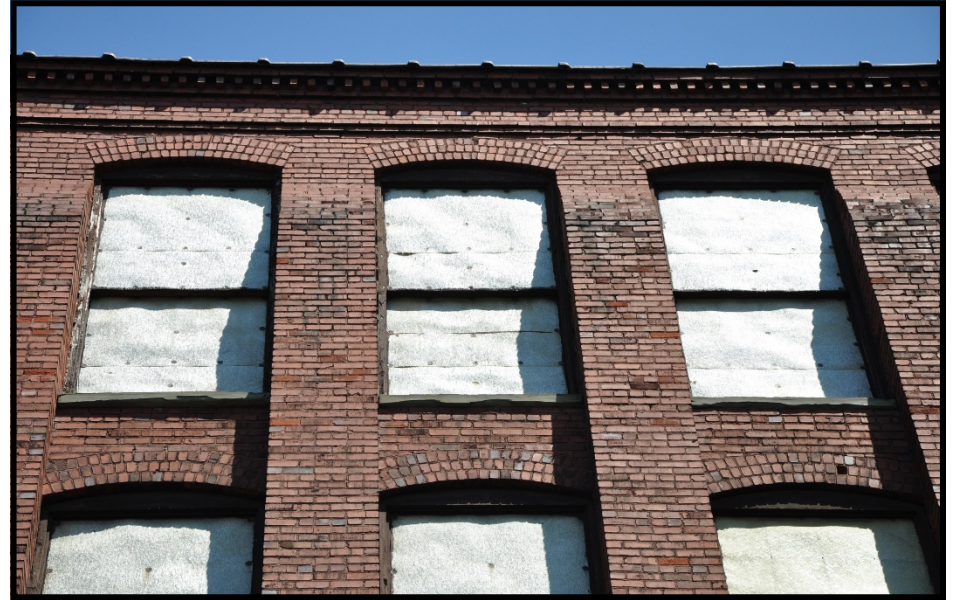
HALL 18: detail view of South side of 1910s building, looking N from Harrison St., showing brick dentils, stringcourse detailing, and use of terra cotta coping. Segmental arched windows may be extant behind the white covering material. Integrity is clear.

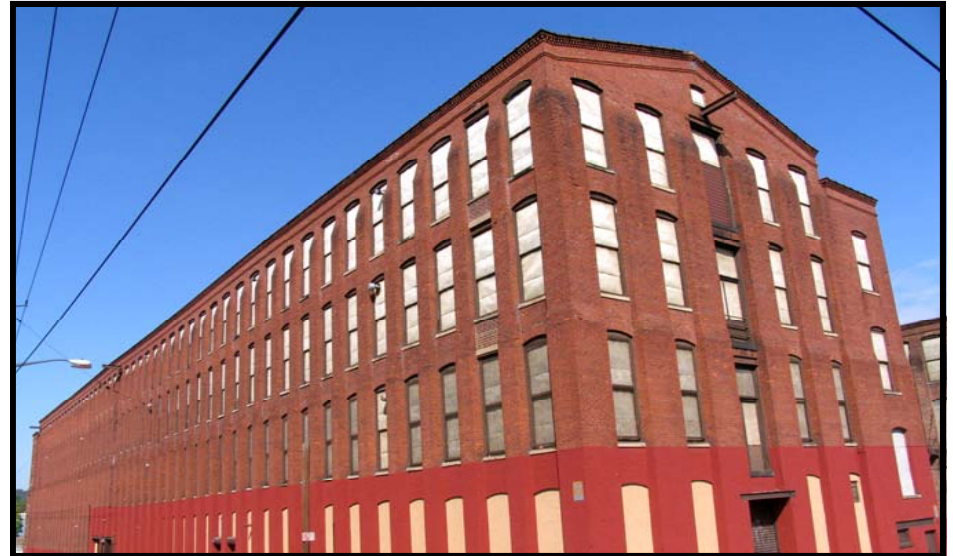
HALL 20: Oblique overview looking NW from corner of Harrison and Summer St., showing East gable end and Harrison St. (South) elevation of the 1910s Hall Mill.
