**COOKE LOCOMOTIVE WORKS / MORRISON MACHINE**  
**1183 Madison Ave, Paterson, NJ B6701 L01**  
 Photographs, historic / contemporary

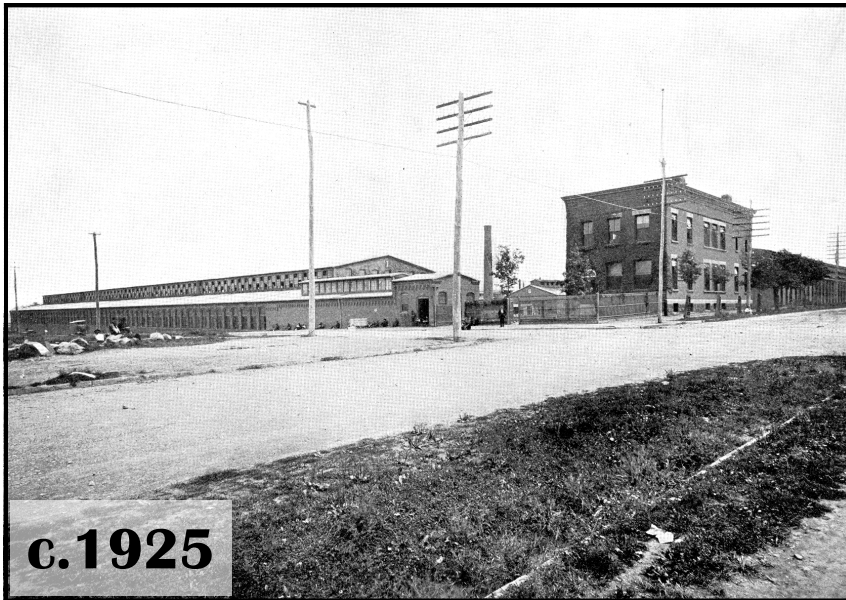
**COOKE 1:** c.1925 looking SE across Getty / Madison intersection, administration building rt. center, wash house & foundry left center

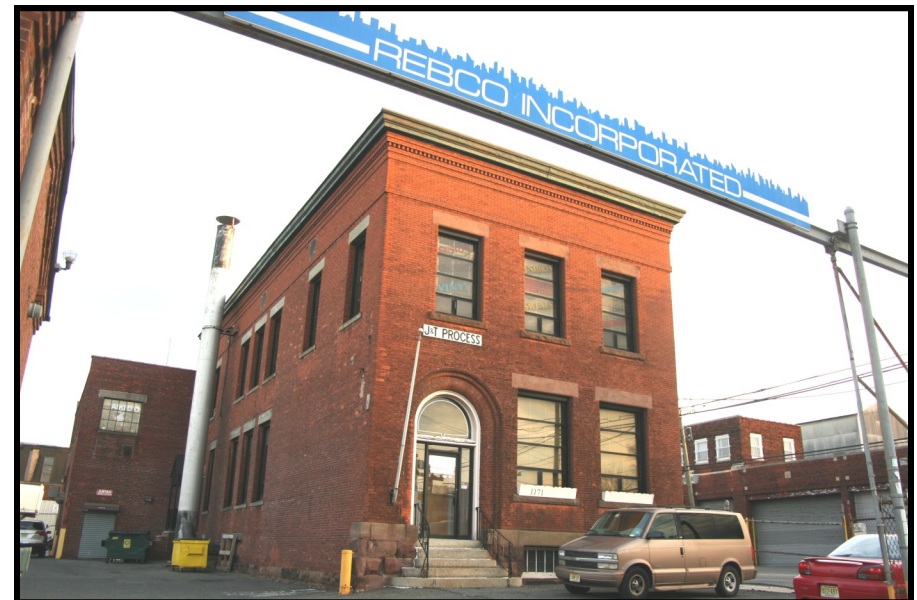
**COOKE 2:** Administration Building, oblique view looking SW, showing façade and east side. Note 1920s addition at rear.

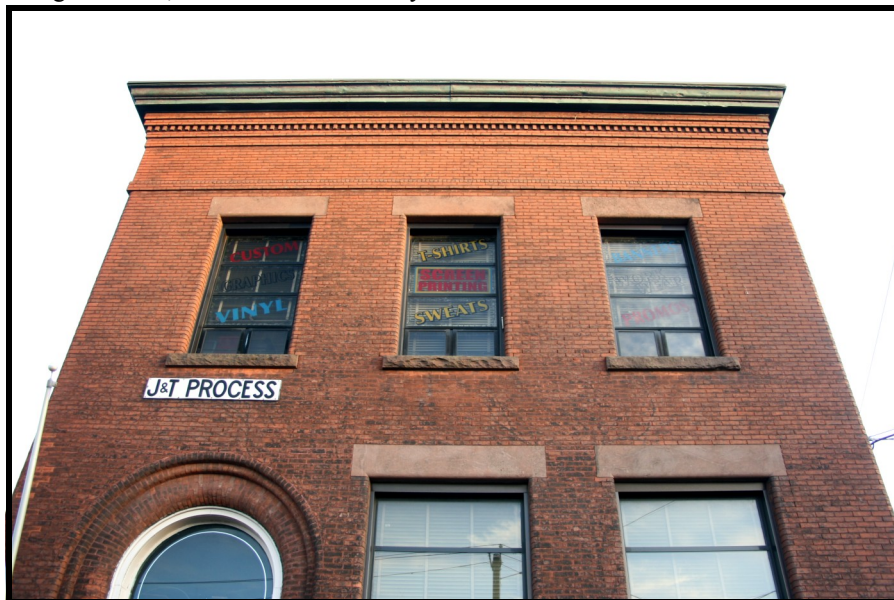
**COOKE 3:** Administration Building, looking S, showing N façade. Note intact cornice detail, dentils, sandstone lintels, cut stone sills, rounded brick circular entrance.

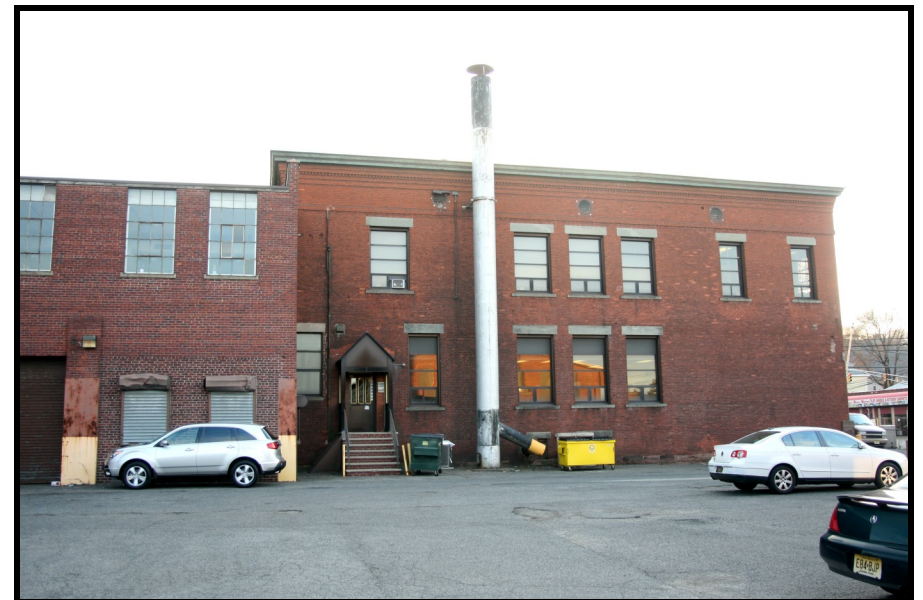
**COOKE 4:** Administration Building, looking W, showing E side. Note 1920s addition at rear.

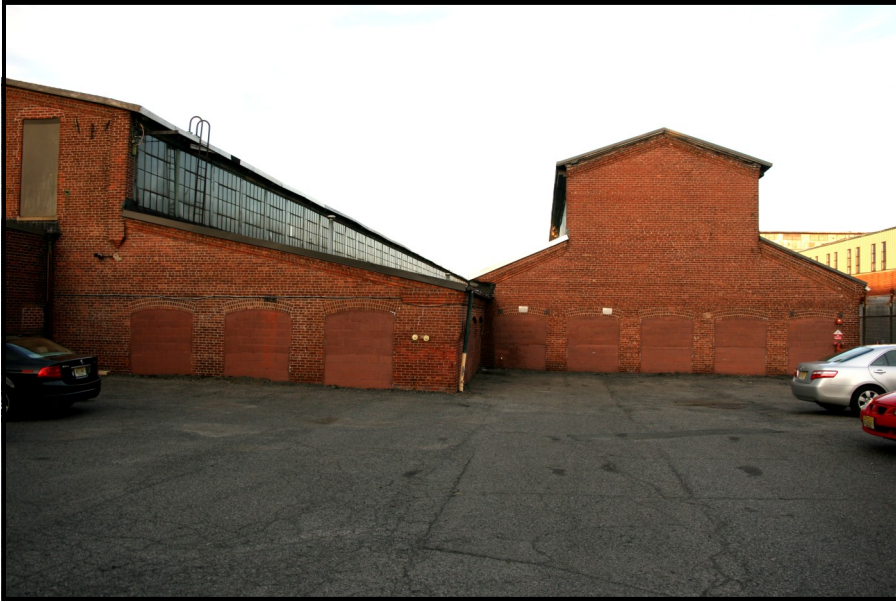
**COOKE 5:** looking E, showing building rt. center, wash house & foundry lft. center

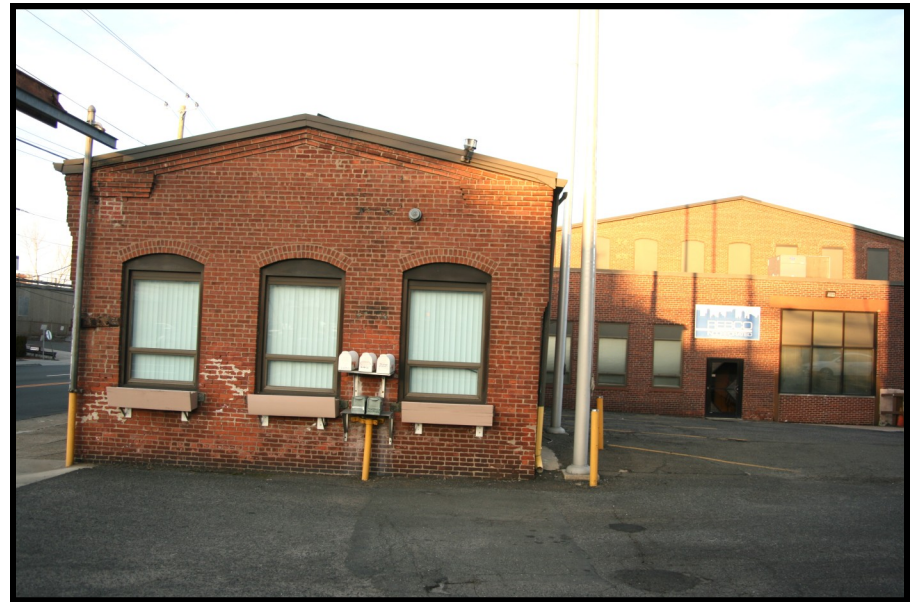
**COOKE 6:** Wash House façade looking E, showing gable of Machine Shop at right rear. 1920-50s brick addition to front of Machine shop is also visible.

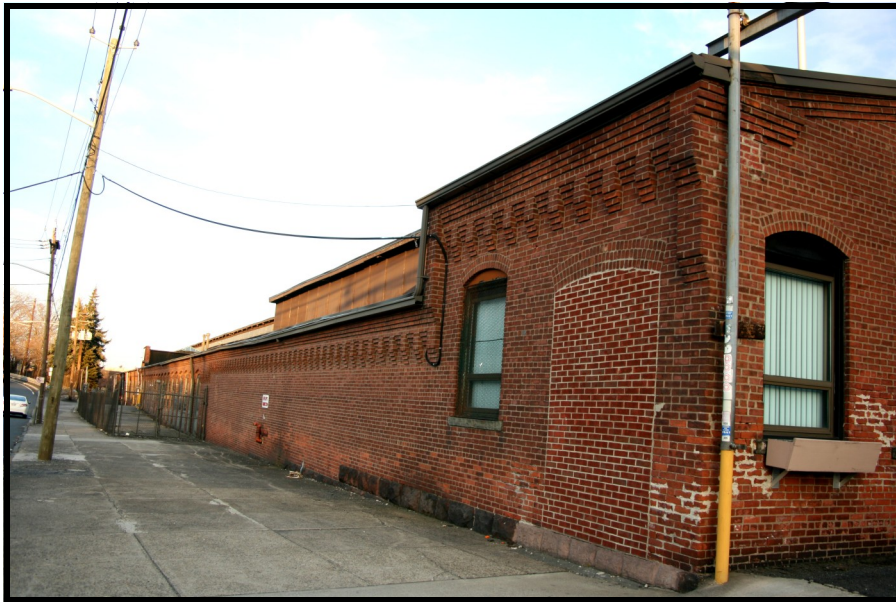
**COOKE 7:** Wash House & Machine Shop, looking SE, Madison Ave at left. Note intact corbelling detail running length of the 200 ft. machine shop.

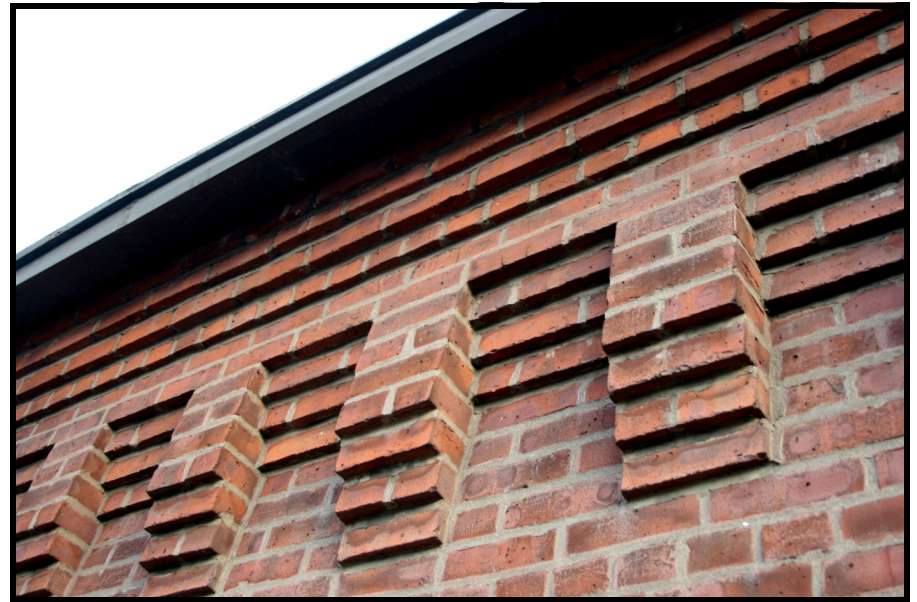
**COOKE 8:** detail view of stepped corbelling detail along cornice of Machine Shop.
